Lenovo Flex System x280 X6, x480 X6, and x880 X6 Compute Node Installation and Service Guide

Machine Types: 7196, 4258

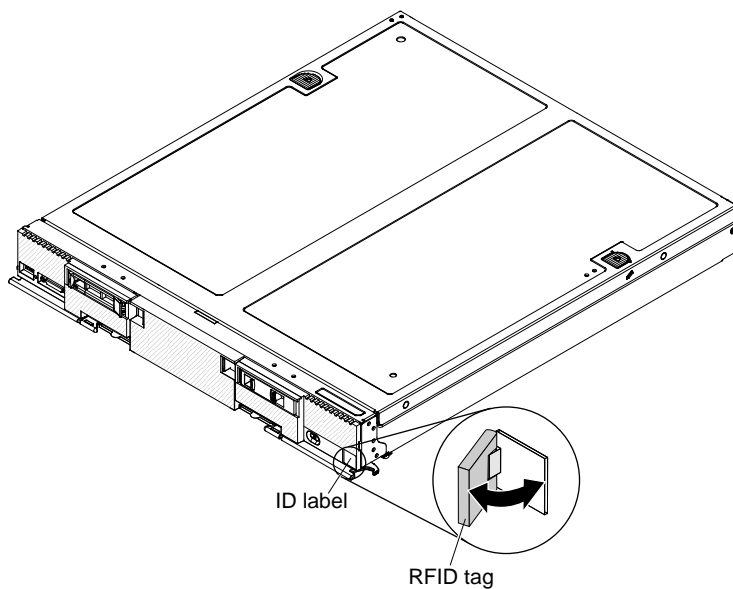
The model number and serial number are on the ID label on the bezel on the front of the compute node, and on a label on the bottom of the compute node that is visible when the compute node is not in the Lenovo Flex System chassis. If the compute node comes with an RFID tag, the RFID tag covers the ID label on the bezel on the front of the compute node but you can open the RFID tag to see the ID label behind it.

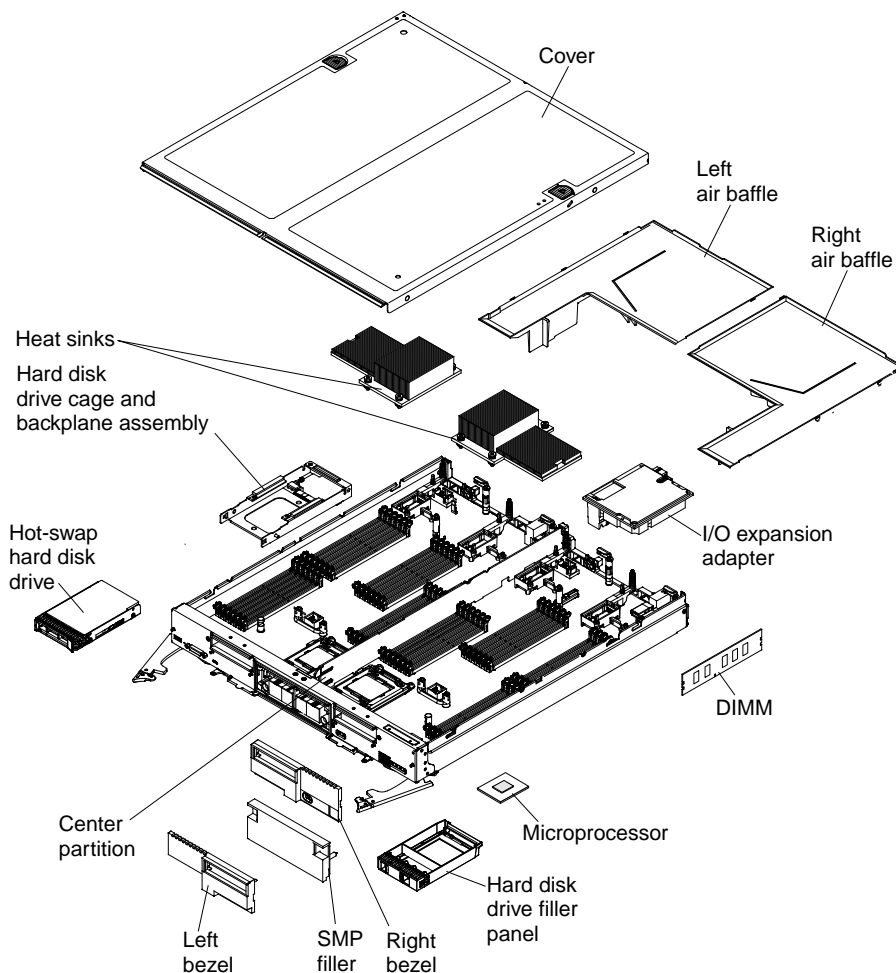
The following illustration shows the major components of the compute node.

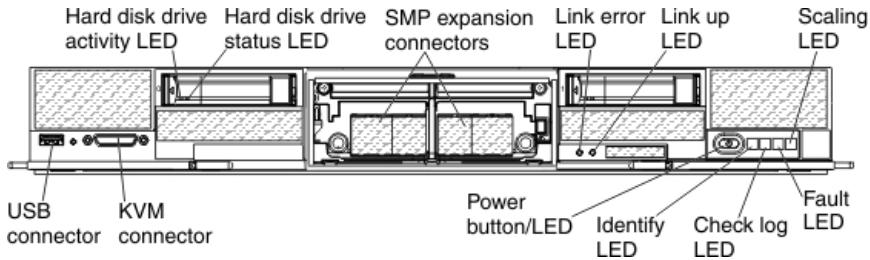
The following illustration identifies the buttons, connectors, and LEDs on the control panel.

Hard disk drive activity LED

When this green LED is lit, it indicates that the hard disk drive is powered on. When flashing, this LED indicates that the drive is in use.

When this yellow LED is lit, it indicates that an error has occurred with the hard disk drive. The LED turns off only after the error is corrected. You can check the CMM event log to determine the source of the condition. For more information, see “Viewing event logs without restarting the compute node” on page 68.

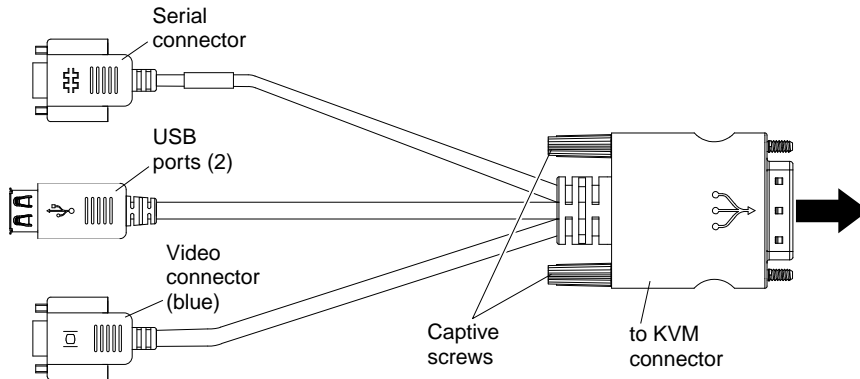
Use the console breakout cable to connect external I/O devices to the compute node. The console breakout cable connects through the KVM connector (see “Compute node controls, connectors, and LEDs” on page 14). The console breakout cable has connectors for a display device (video), two USB connectors for a USB keyboard and mouse, and a serial interface connector.

The following illustration identifies the connectors and components on the console breakout cable.

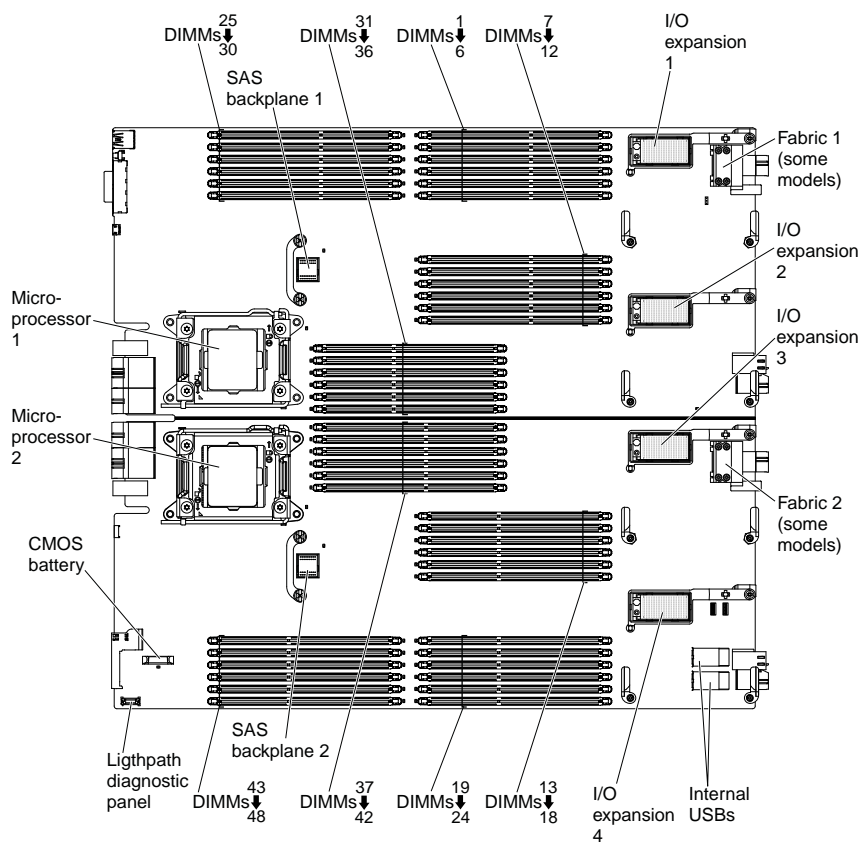
The following illustration shows the system-board components, including connectors for user-installable optional devices, in the compute node.

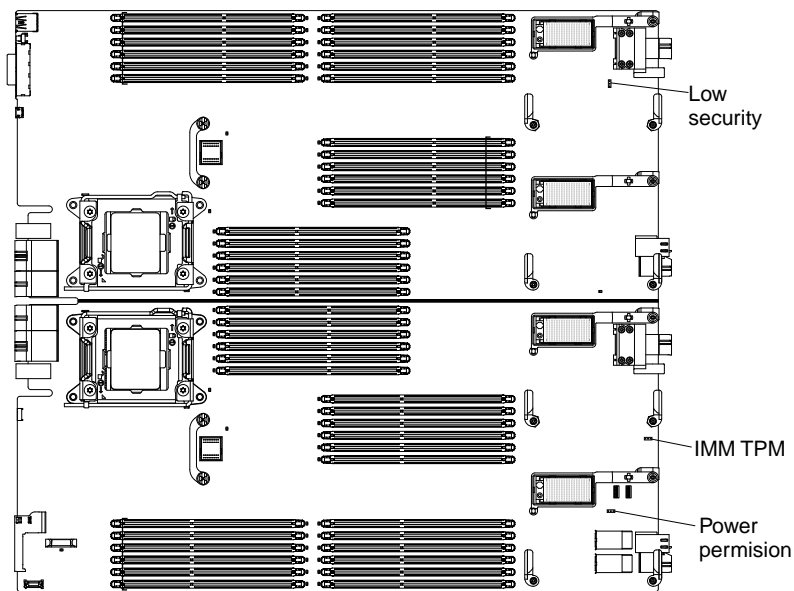
The following illustration shows the locations of the jumpers on the system board.

Jumper number	Description
IMM TPM (JP2461)	Two-pin jumper. The default is no jumper. Place a jumper on pins 1 and 2 to indicate a physical presence to the IMM2 TPM chip.
Low Security (J2101)	Three-pin jumper block. The default position is pins 2 and 3.
Power permission (JP9601)	Two-pin jumper block. The default is no jumper. Place a jumper on pins 1 and 2 to force power permission from the IMM2 to the real time management module (RTMM).

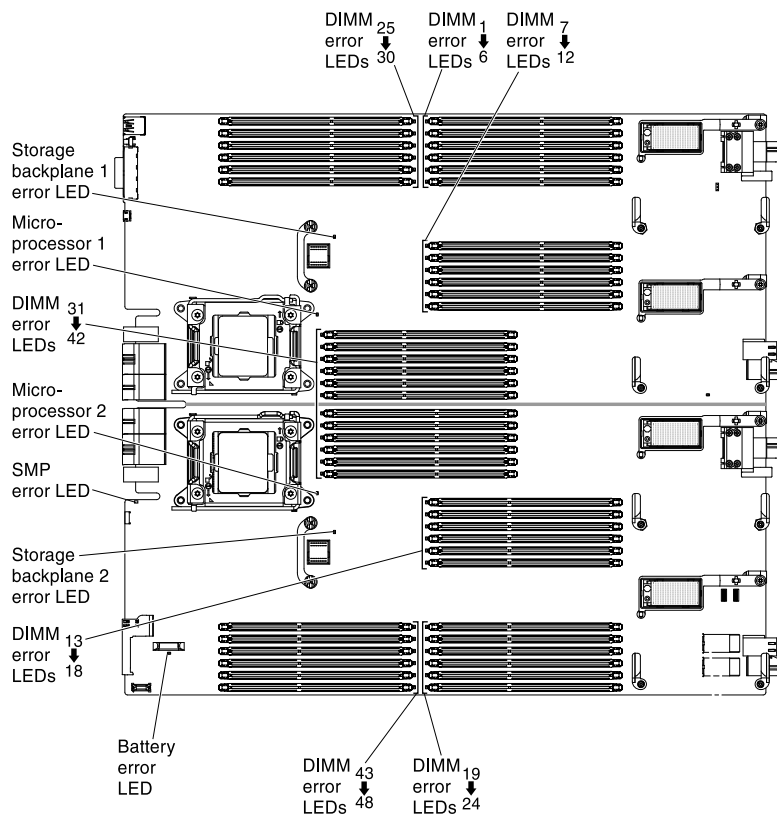
The following illustration shows the location of the LEDs on the system board.

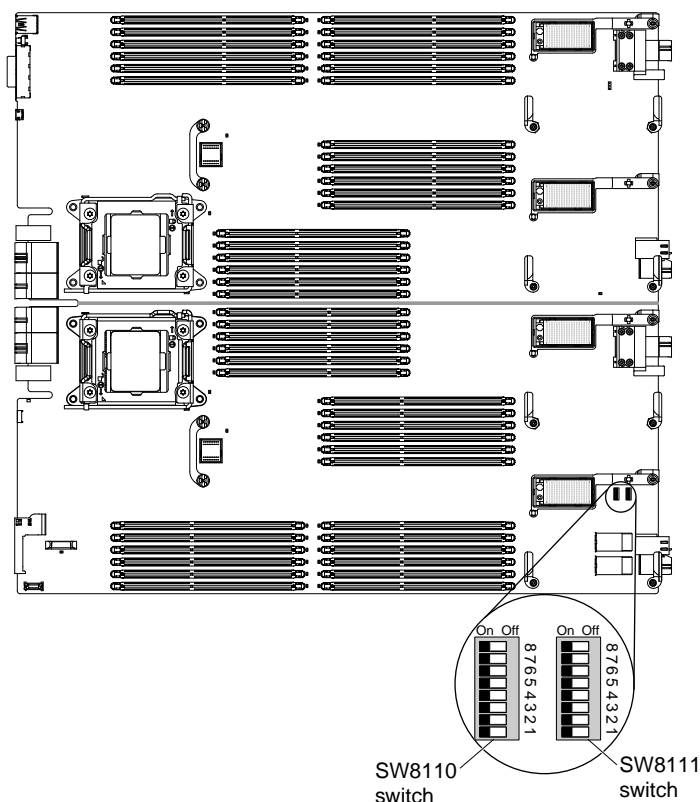
The following illustration shows the location of the switch blocks on the system board.

Switch number	Description	Switch setting	Definition
SW8110-1	Password override	The default position is off.	Changing this switch to the on position overrides the power-on password.
SW8110-2	UEFI TPM	The default position is off.	Changing this switch to the on position indicates a physical presence to the TPM.
SW8110-3	Real time clock (RTC) reset	The default position is off.	Changing this switch to the on position resets the RTC. A momentary toggle is all that is required. To avoid excessive CMOS battery drain, do not leave this switch in the on position.
SW8110-4	Boot backup IMM2	The default position is off.	When the switch is in the default off position, the compute node will boot by using the primary IMM2 firmware. When the switch is in the on position, the compute node will boot by using a backup of the IMM2 firmware.

Switch number	Description	Switch setting	Definition
SW8110-5	Boot backup UEFI	The default position is off.	Changing this switch to the on position forces the compute node to boot from the backup UEFI image.
SW8110-6	IMM force update	The default position is off.	Changing this switch to the on position bypasses the operational firmware image and performs a IMM firmware update, if the normal firmware update procedure results in an inoperative IMM. Note: Use this switch only if the normal firmware update procedure fails and the operational firmware image is corrupted. Use of this switch disables normal baseboard management controller operation.
SW8110-7	IMM SPI ROM Chip Select	The default position is off.	Changing this switch to the on position forces the compute node to select system SPI ROM0 or ROM1.
SW8110-8	Real time management module (RTMM) flash bypass	The default position is off.	Changing this switch to the on position forces the compute node to use RTMM ROM instead of flash.

5. Locate the boot backup UEFI switch on the switch block and move the switch to the On position (see “System-board switches” on page 21).
6. Replace the cover and reinstall the compute node in the Lenovo Flex System chassis (see “Installing the compute node cover” on page 886 and “Installing a compute node in a chassis” on page 873).

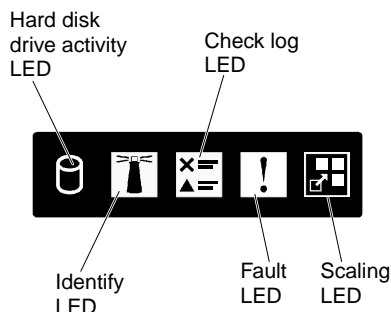
1. Look at the control panel on the front of the compute node.

- If the check log LED is lit, it indicates that a condition that causes an event to log in the IMM event log has occurred.

- If the fault LED is lit, it indicates that an error has occurred; view the light path diagnostics panel and LEDs to isolate the failing component.
2. To view the light path diagnostics LEDs, select one of the following procedures:

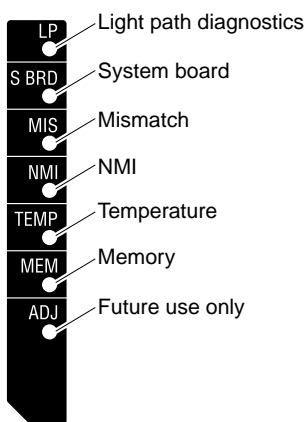
The following illustration shows the LEDs on the light path diagnostics panel.

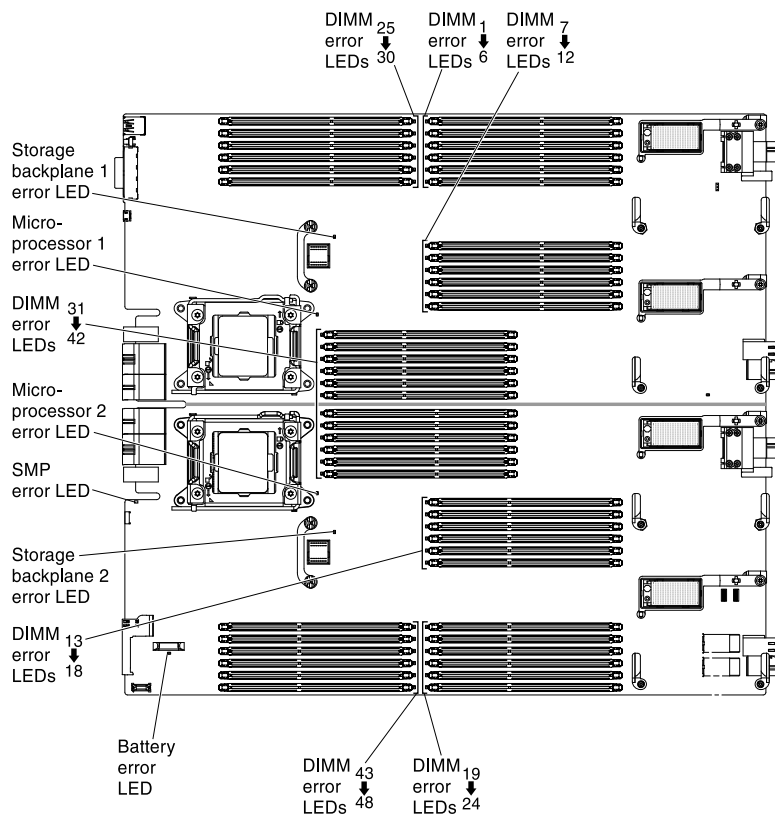
The following illustration shows the locations of the light path diagnostics LEDs on the system board.

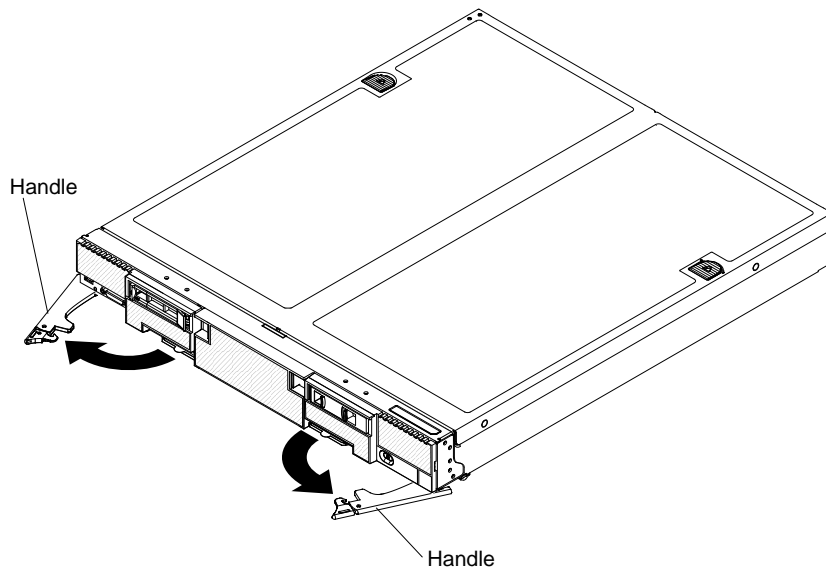
- Step 1. Remove the SMP expansion connector, if the compute node is part of a multi-node complex (see “Removing a scalability and performance connector” on page 913).
- Step 2. Open the front handles as shown in the illustration. The compute node moves out of the node bay approximately 0.6 cm (0.25 inch).

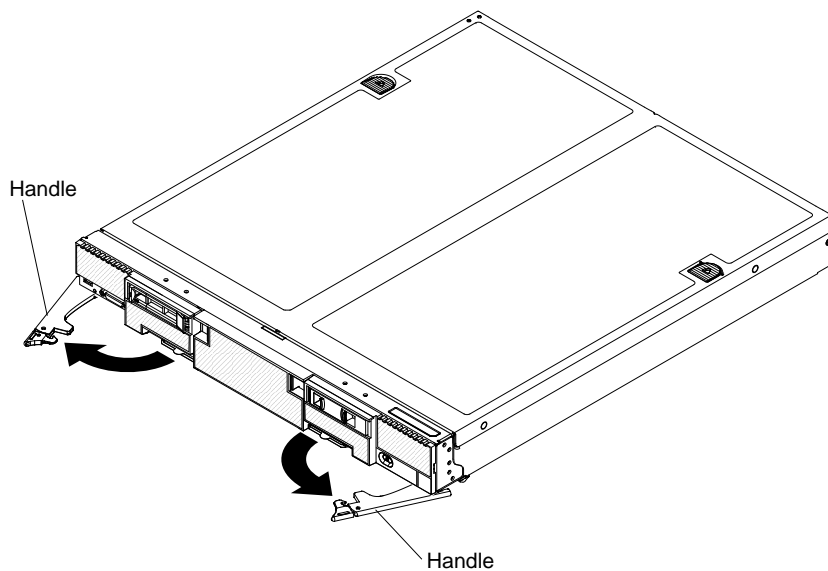
To install the compute node in a chassis, complete the following steps.

Step 1. Select the node bay.

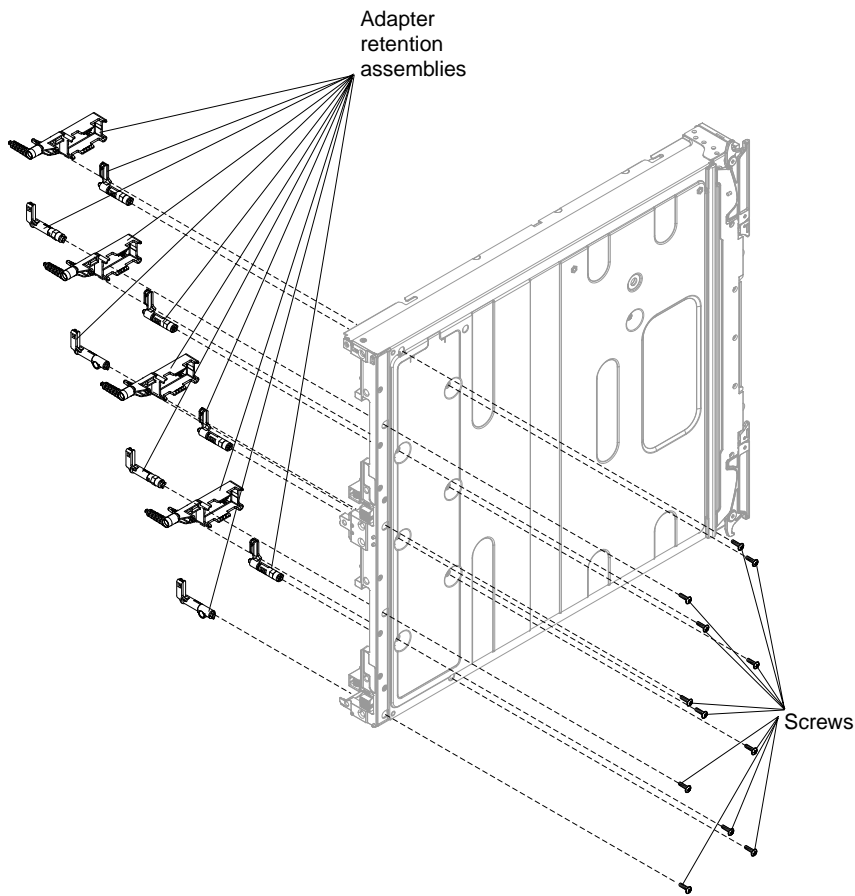
To remove the adapter-retention assembly, complete the following steps.

- Step 1. Remove the cover (see “Removing the compute node cover” on page 885).
- Step 2. Remove the air baffles.
- Step 3. If necessary, remove the I/O expansion adapters (see “Removing an I/O expansion adapter” on page 910).
- Step 4. Carefully place the chassis on the side with the front handle side up.
- Step 5. Using a T9 Torx screwdriver, remove the 12 screws that secure the adapter-retention assembly.
- Step 6. Lift the adapter-retention assembly from the system board.
- Step 7. Carefully return the chassis to the bottom-side-down orientation.

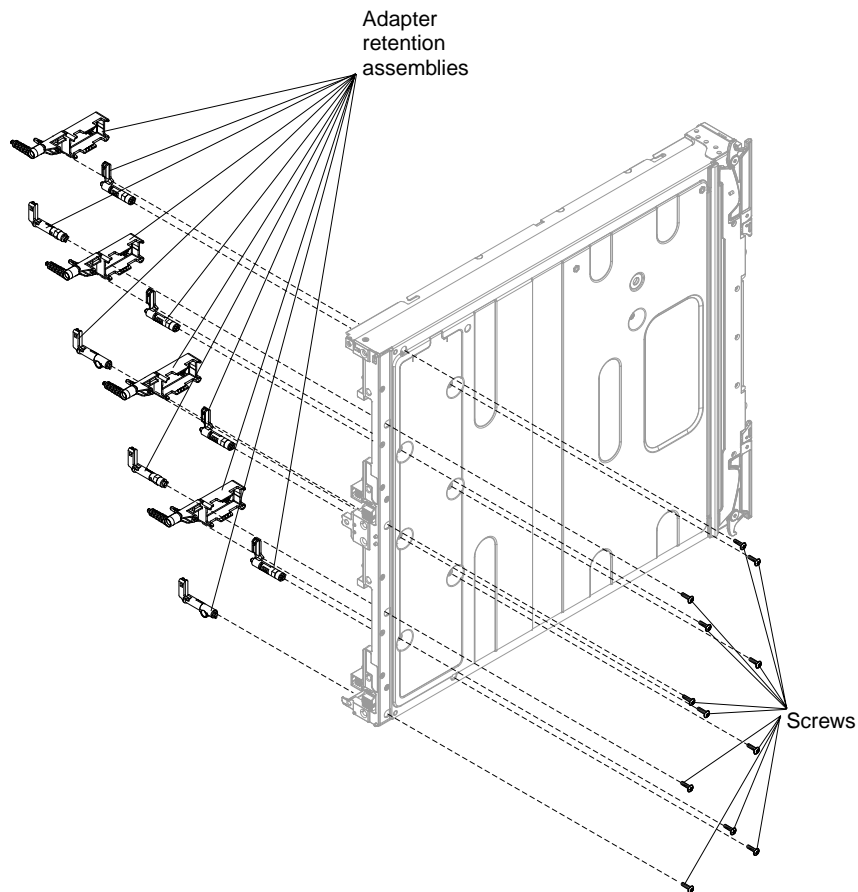
To install the adapter-retention assembly, complete the following steps.

- Step 1. Remove the cover (see “Removing the compute node cover” on page 885).
- Step 2. Remove the air baffles.
- Step 3. Carefully place the chassis on the side with the front handle side up.
- Step 4. Align the adapter-retention assembly on the system board.
- Step 5. Using a T9 Torx screwdriver, install the screws that secure the adapter-retention assembly.
- Step 6. Carefully return the chassis to the bottom-side-down orientation.
- Step 7. Install the I/O expansion adapters, if you removed them (see “Installing an I/O expansion adapter” on page 910).
- Step 8. Install the air baffles.

Attention: Install the air baffles with the arrow indicating airflow direction pointing to the rear of the compute node.

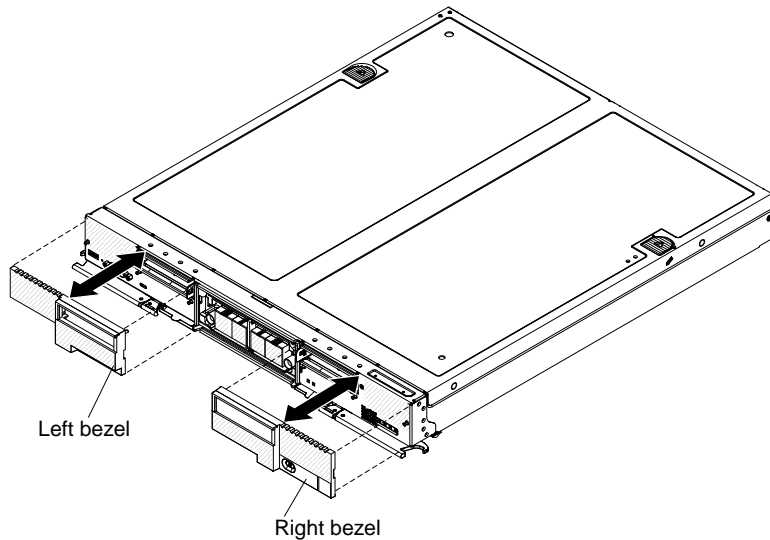
To remove the bezel, complete the following steps.

Step 1. Use a flat-blade screwdriver to carefully pull the bezel from the compute node.

Step 2. Lift the bezel from the compute node.

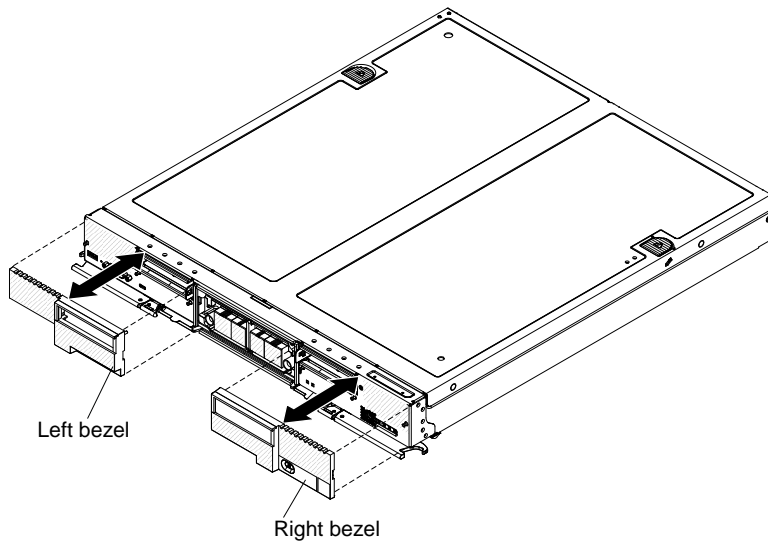
To install the bezel, complete the following steps.

- Step 1. Position the bezel on the front of the compute node. Make sure that the clips on the back of the bezel are inserted into the pins on the front of the drive tray.
- Step 2. Press the bezel securely against the chassis. Make sure that the bezel is pressed flat against the chassis around the power button, to maintain access to the power button.

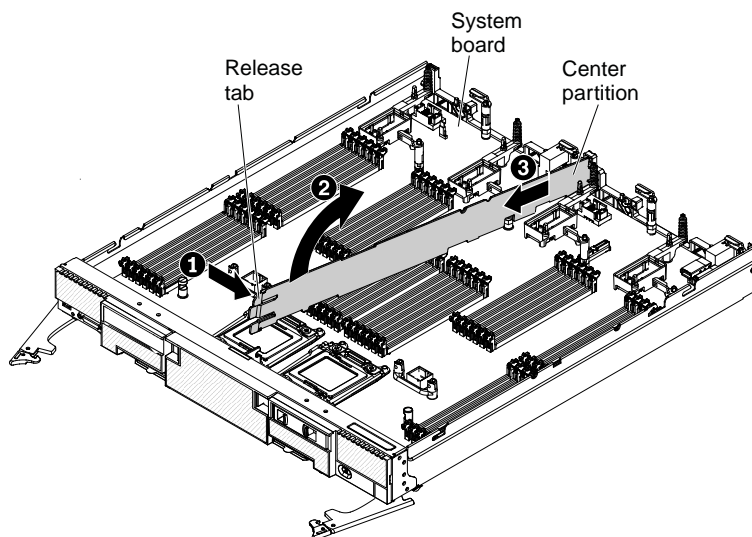
To remove the center partition, complete the following steps.

- Step 1. Remove the cover (see “Removing the compute node cover” on page 885).

- Step 2. Remove the air baffles.
- Step 3. Press the center partition on the side to release it from the compute node.
- Step 4. Lift the center partition from the compute node.

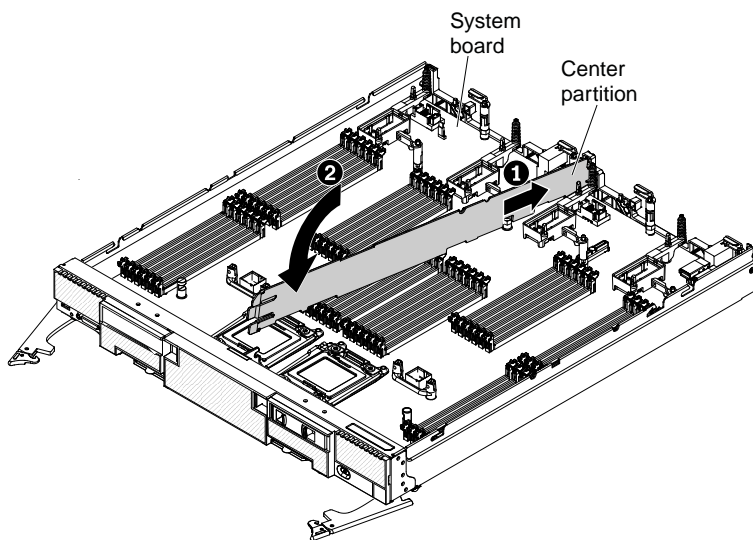
To install the center partition, complete the following steps.

- Step 1. Remove the cover (see “Removing the compute node cover” on page 885).
- Step 2. Remove the air baffles.
- Step 3. Place the center partition into position at the rear of the compute node.
- Step 4. Rotate the center partition and secure it at the front of the compute node.
- Step 5. Install the air baffles.

Attention: Install the air baffles with the arrow indicating air airflow direction pointing to the rear of the compute node.

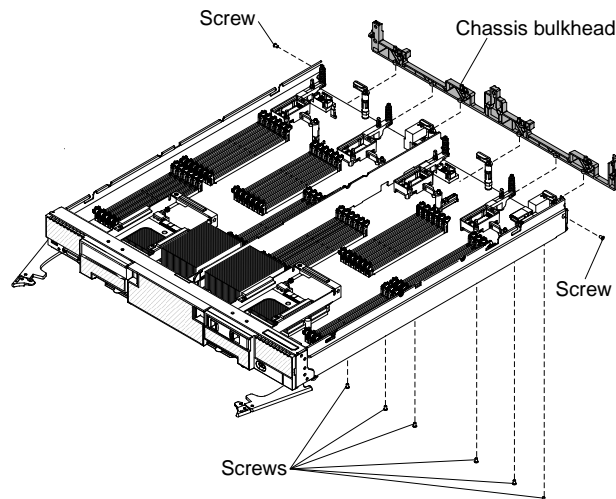
To remove the chassis bulkhead, complete the following steps.

- Step 1. Remove the cover (see “Removing the compute node cover” on page 885).
- Step 2. Remove the air baffles.
- Step 3. Remove the center partition (see “Removing the center partition” on page 879).
- Step 4. Remove the fabric connectors (see “Removing a fabric connector” on page 902).
- Step 5. Carefully place the chassis on the side with the front handle side up.
- Step 6. Using a T8 Torx screwdriver, remove the screws that secure the bulkhead from the bottom of the chassis.
- Step 7. Carefully return the chassis to the bottom-side-down orientation.
- Step 8. Using a T8 Torx screwdriver, remove the screws that secure the bulkhead from the sides of the chassis.
- Step 9. Lift the chassis bulkhead from the chassis.

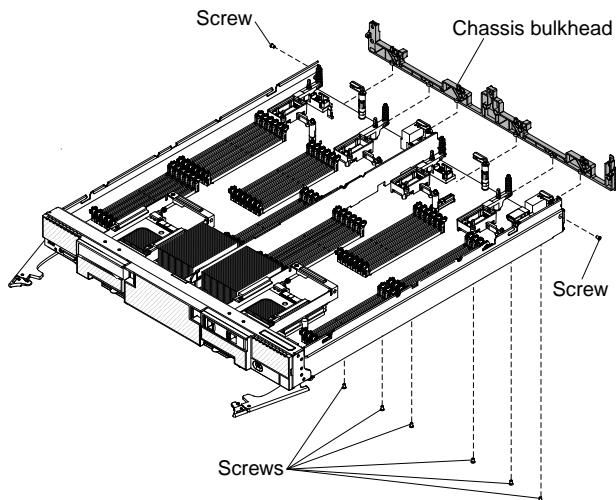
To install the chassis bulkhead, complete the following steps.

- Step 1. Remove the cover (see “Removing the compute node cover” on page 885).
- Step 2. Remove the air baffles.
- Step 3. Remove the center partition (see “Removing the center partition” on page 879).

- Step 4. Remove the fabric connectors (see “Removing a fabric connector” on page 902).
- Step 5. Position the bulkhead in the chassis.
- Step 6. Using a T8 Torx screwdriver, install the screws that secure the bulkhead to the sides of the chassis.

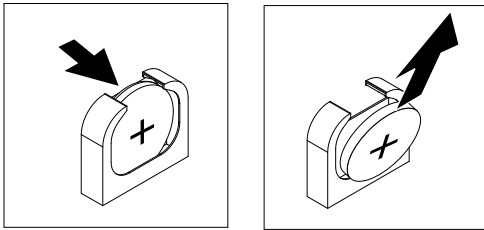
- Step 1. Remove the cover (see “Removing the compute node cover” on page 885).
- Step 2. Locate the CMOS battery on the system board (see “System-board connectors” on page 19).
- Step 3. If a cover is over the CMOS battery, remove the cover.
- Step 4. Pivot the CMOS battery toward the middle of the compute node.

- Step 5. Lift the CMOS battery from the socket.

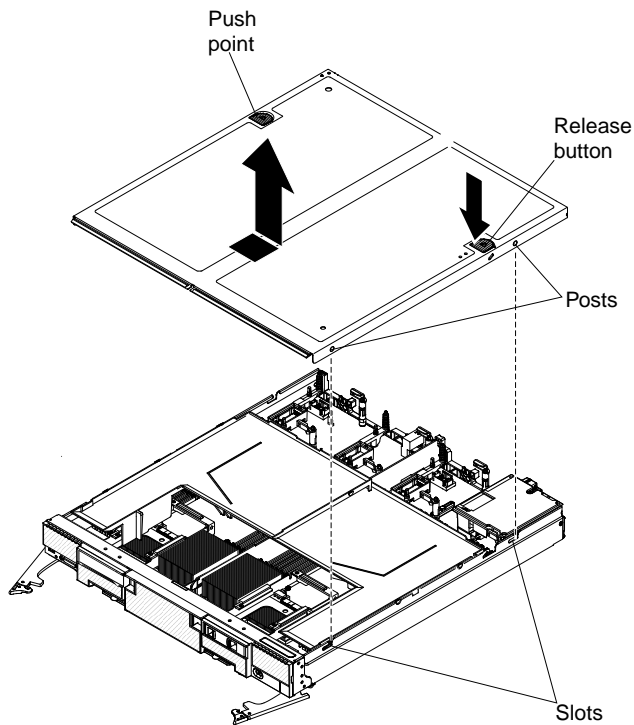
- Step 1. Press on the release button and the push point at the same time and slide the cover toward the rear of the compute node.
- Step 2. Lift the cover away from the compute node.

Step 3. Lay the cover flat or store it for future use.

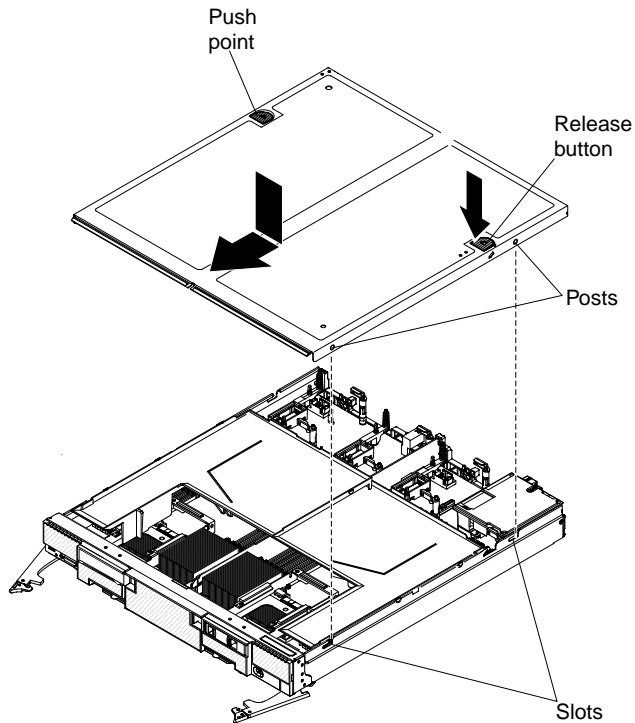
- Step 1. Carefully lay the compute node on a flat, static-protective surface, orienting the compute node with the bezel pointing toward you.
- Step 2. Orient the cover so that the posts on the inside of the cover slide into the slots on the compute node.

Step 3. Hold the front of the compute node and slide the cover forward to the closed position, until it clicks into place.

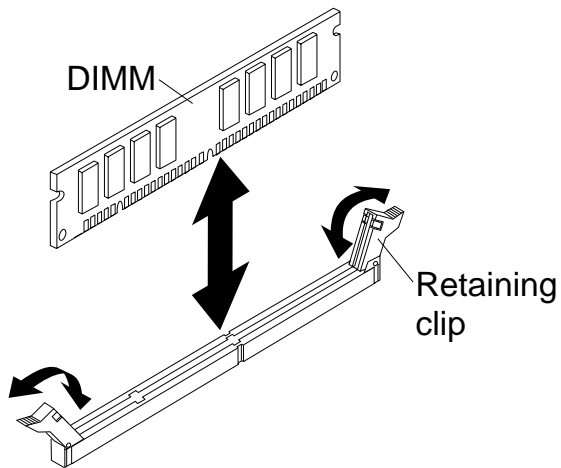
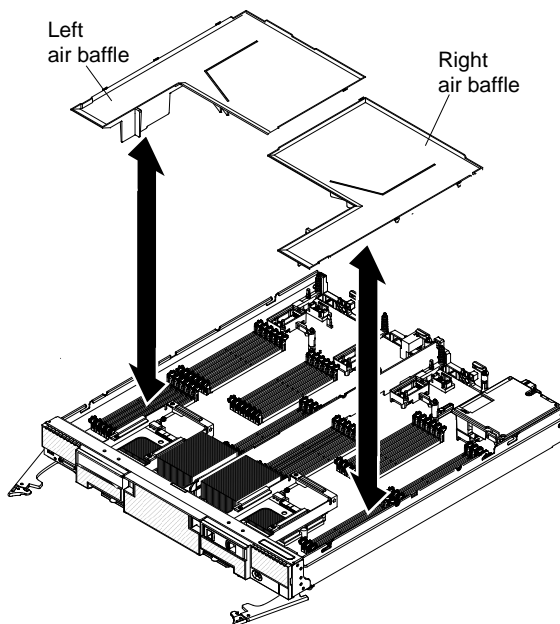
To remove a DIMM, complete the following steps.

- Step 1. Remove the cover (see “Removing the compute node cover” on page 885).
- Step 2. Remove the air baffle that is installed over the DIMM connector.

- Step 3. Locate the DIMM connectors (see “System-board connectors” on page 19). Determine which DIMM you want to remove from the compute node.

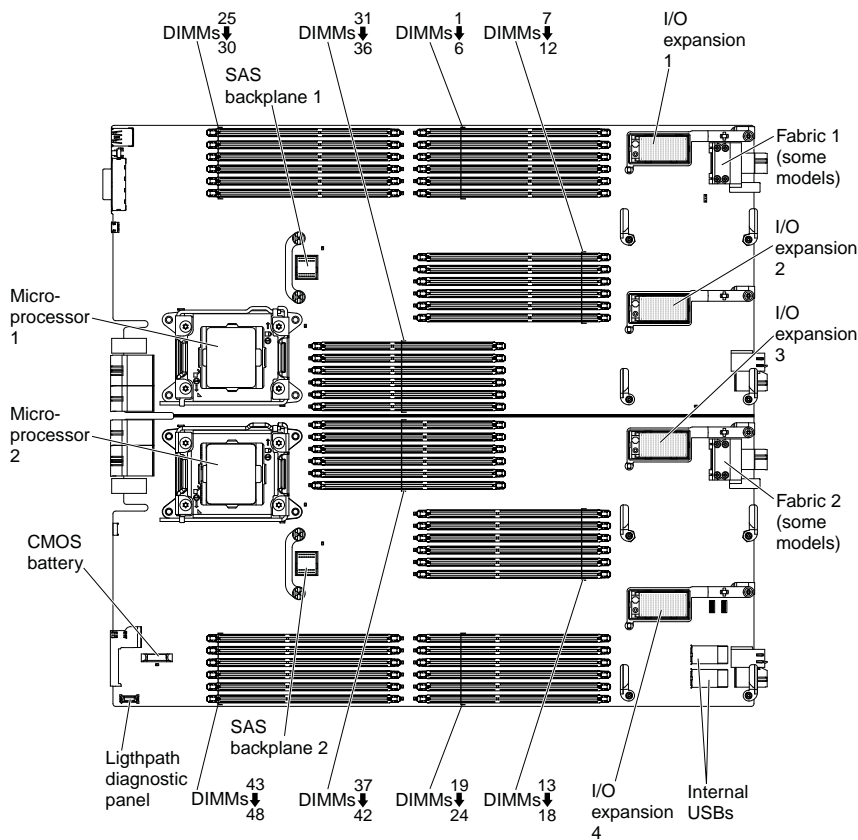
The following illustration shows the system-board components, including the DIMM connectors.

The DDR-3 DIMMs are accessed internally through the integrated memory controllers on the microprocessors. Each microprocessor controls 24 DIMMs. Eight scalable memory buffers provide the interface between the microprocessor memory controller and the DIMMs. The scalable memory controllers interface using one scalable memory interconnect 2 (SMI2) channel. Each SMI2 channel supports two DDR-3 memory buses and each DDR-3 bus connects to up to three DIMMs.

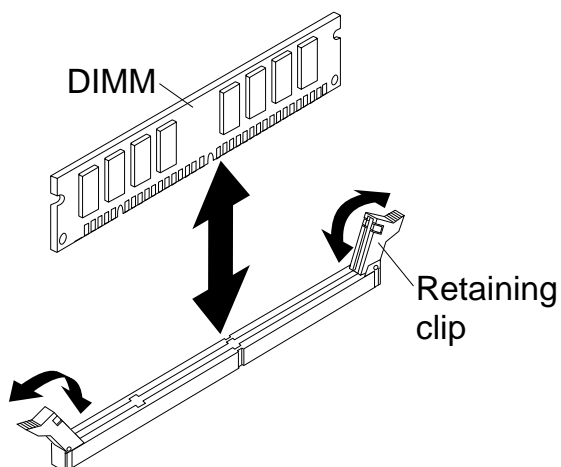
- Step 1. Remove the cover (see “Removing the compute node cover” on page 885).
- Step 2. Read the documentation that comes with the DIMM.
- Step 3. Remove the air baffle installed over the DIMM connector.
- Step 4. Locate the DIMM connectors (see “System-board connectors” on page 19). Determine in which DIMM connector you want to install the DIMM.
- Step 5. Touch the static-protective package that contains the DIMM to any *unpainted* metal surface on the Lenovo Flex System chassis or any *unpainted* metal surface on any other grounded rack component in the rack in which you are installing the DIMM for at least 2 seconds; then, remove the DIMM from the package.

- Step 6. Make sure that both retaining clips on the DIMM connector are in the open position.
- Step 7. Turn the DIMM so that the DIMM keys align correctly with the DIMM connector on the system board.

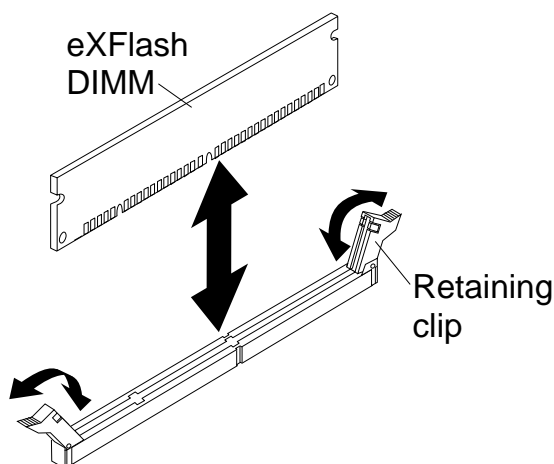
To remove an eXFlash DIMM, complete the following steps.

Step 1. Remove the cover (see “Removing the compute node cover” on page 885).

- Step 2. Remove the air baffle that is installed over the DIMM connector.
- Step 3. Locate the DIMM connectors (see “System-board connectors” on page 19). Determine which eXFlash DIMM you want to remove from the compute node.

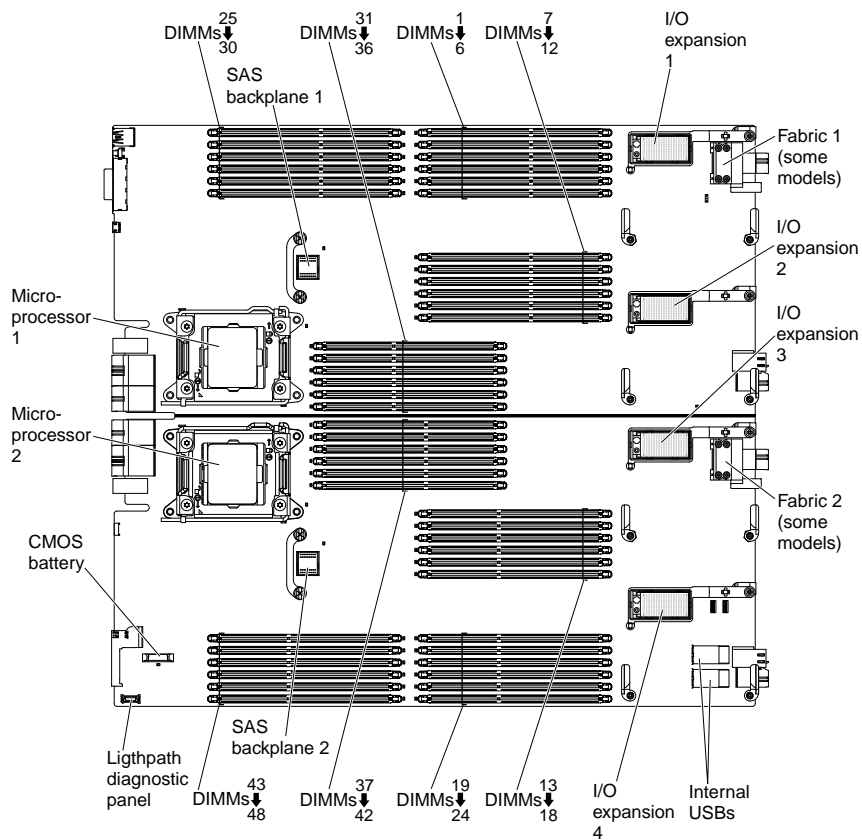
The following illustration shows the system-board components, including the DIMM connectors.

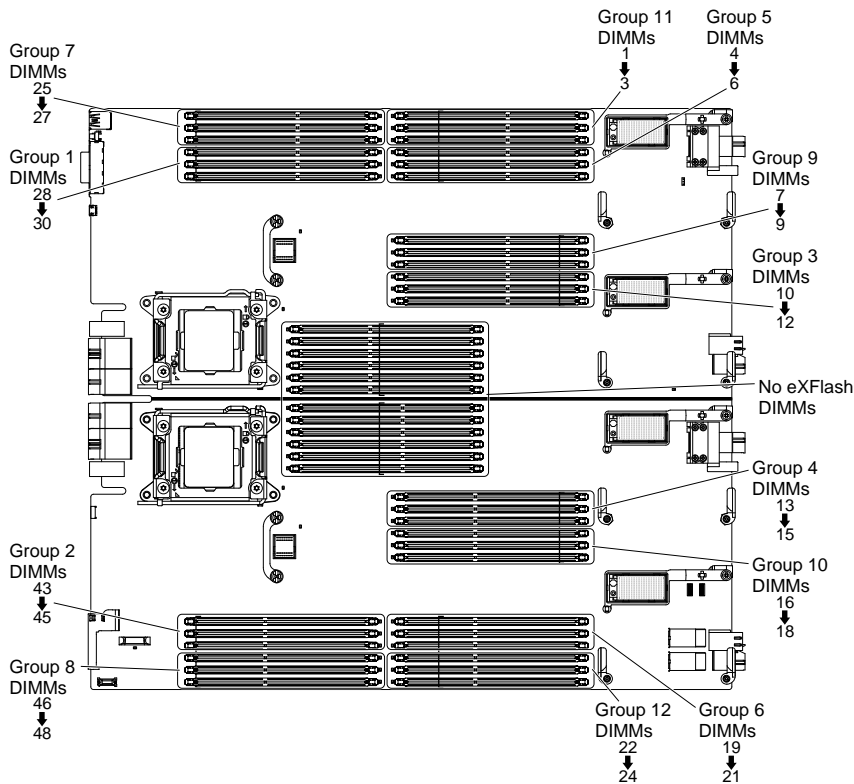
You install eXFlash DIMMs in groups. The following illustration shows the eXFlash DIMM groups and the DIMM connectors.

- Install the first eXFlash DIMM in group 1, the next eXFlash DIMM in group 2, and install subsequent eXFlash DIMMs in the next group in sequence.
- For configurations exceeding 32 DIMMs, if all DIMM connectors within a group are populated, install the eXFlash DIMMs starting with the lowest available group number.
- In an unbalanced DIMM configuration (that is, channels populated with unequal numbers of DIMMs), start the installation of the first eXFlash DIMM with the lowest group number containing the smallest number of DIMMs per channel. For example, if group 1 has 2 DIMMs and group 2 has 1 DIMM, start installation of eXFlash DIMMs in group 2. Continue the installation of eXFlash DIMMs in each group in a circular order across the system board.

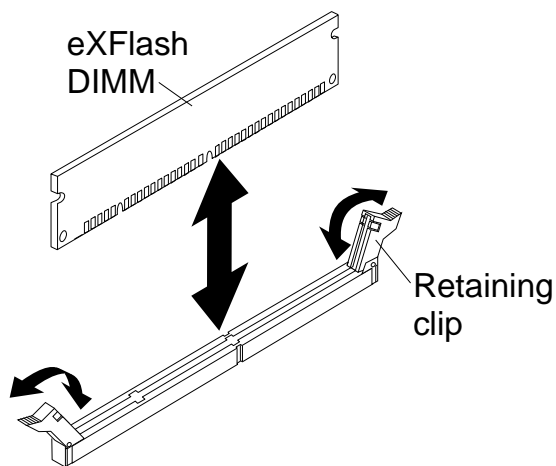
- Step 1. Remove the cover (see “Removing the compute node cover” on page 885).
- Step 2. Read the documentation that comes with the eXFlash DIMM.
- Step 3. Remove the air baffle installed over the DIMM connector.
- Step 4. Locate the DIMM connectors (see “System-board connectors” on page 19). Determine in which DIMM connector you want to install the eXFlash DIMM.
- Step 5. Touch the static-protective package that contains the eXFlash DIMM to any *unpainted* metal surface on the Lenovo Flex System chassis or any *unpainted* metal surface on any other grounded rack component in the rack in which you are installing the eXFlash DIMM for at least 2 seconds; then, remove the eXFlash DIMM from the package.

- Step 6. Make sure that both retaining clips on the DIMM connector are in the open position.
- Step 7. Turn the eXFlash DIMM so that the eXFlash DIMM keys align correctly with the DIMM connector on the system board.

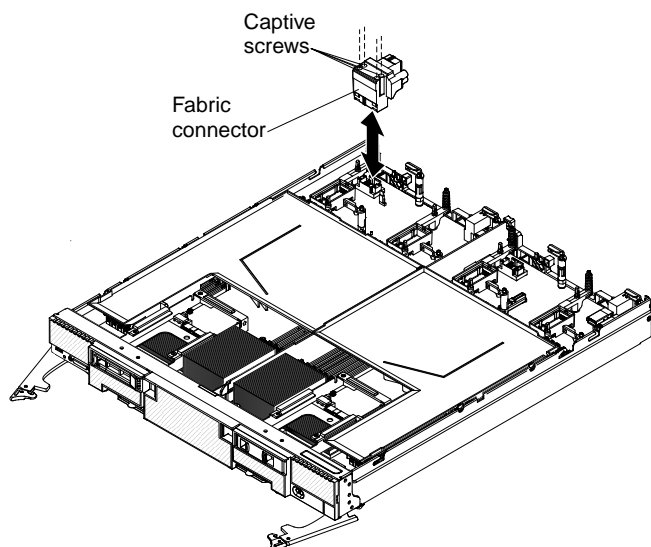
- Step 1. Remove the cover (see “Removing the compute node cover” on page 885).
- Step 2. Locate the fabric connector on the system board.
- Step 3. Using a Phillips #1 screwdriver, loosen the four captive screws that secure the fabric connector.
- Step 4. Lift the fabric connector from the system board and store it in a safe place.

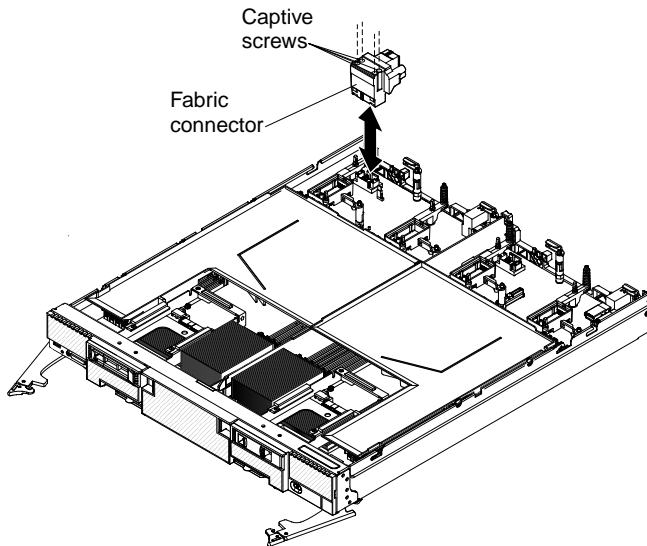
- Step 1. Remove the cover (see “Removing the compute node cover” on page 885).
- Step 2. Locate the fabric connector (see “System-board layouts” on page 19).
- Step 3. Orient the fabric connector on the system board.
- Step 4. Using a Phillips #1 screwdriver, tighten the four captive screws to secure the fabric connector.

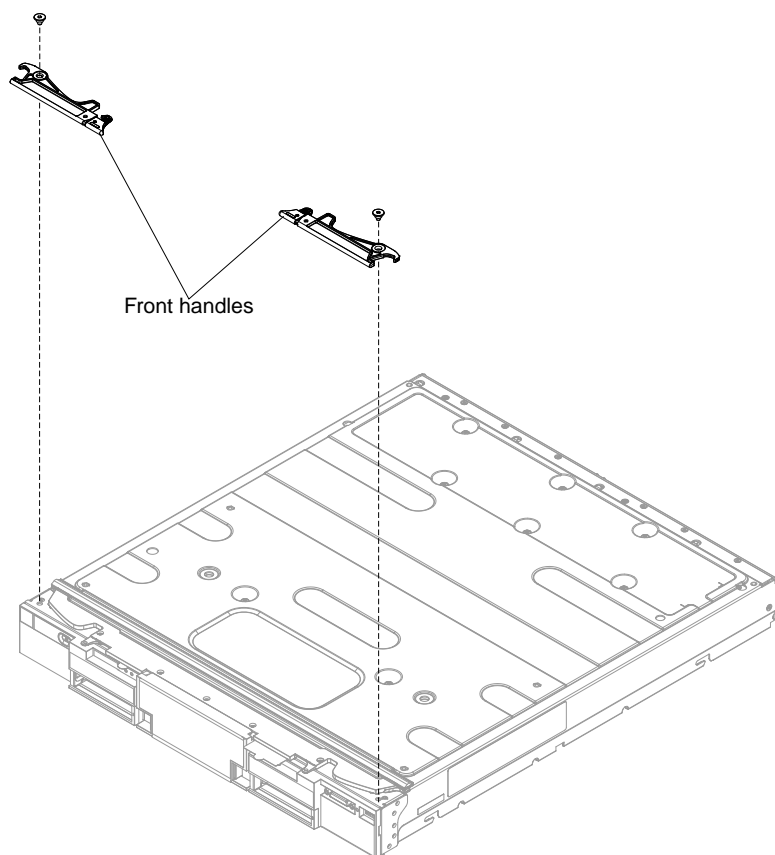
Step 1. Locate the screws that attach the handles to the compute node.

Step 2. Using a T8 Torx screwdriver, remove the screw from each front handle and save the screw in a safe place. Use the same screws when you install the front handles.

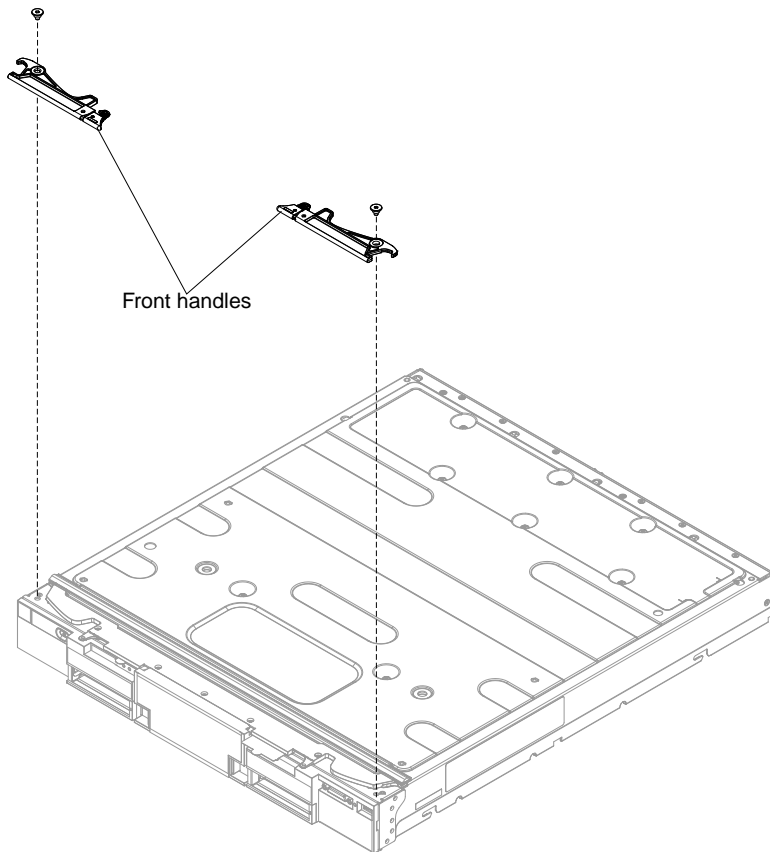
- Step 1. Orient the front handles so that the blue release latches are toward the middle of the compute node.
- Step 2. Align the hole in the handles with the holes on the compute node where the handles are installed.
- Step 3. Using a T8 Torx screwdriver, install the screw that secures each handle. Use the screws that you removed when you removed the handles.

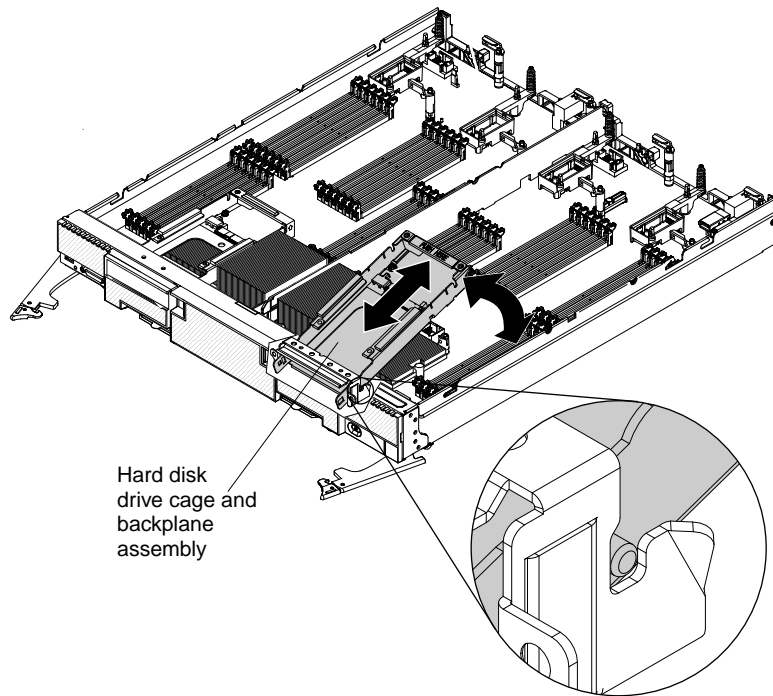
- Step 1. Remove the cover (see “Removing the compute node cover” on page 885).
- Step 2. Remove the hot-swap hard disk drives and hard disk drive bay fillers (see “Removing a hot-swap hard disk drive” on page 908).
- Step 3. Lift up on the rear of the assembly to disconnect it from the connector on the system board.
- Step 4. Remove the assembly from the compute node at an angle.

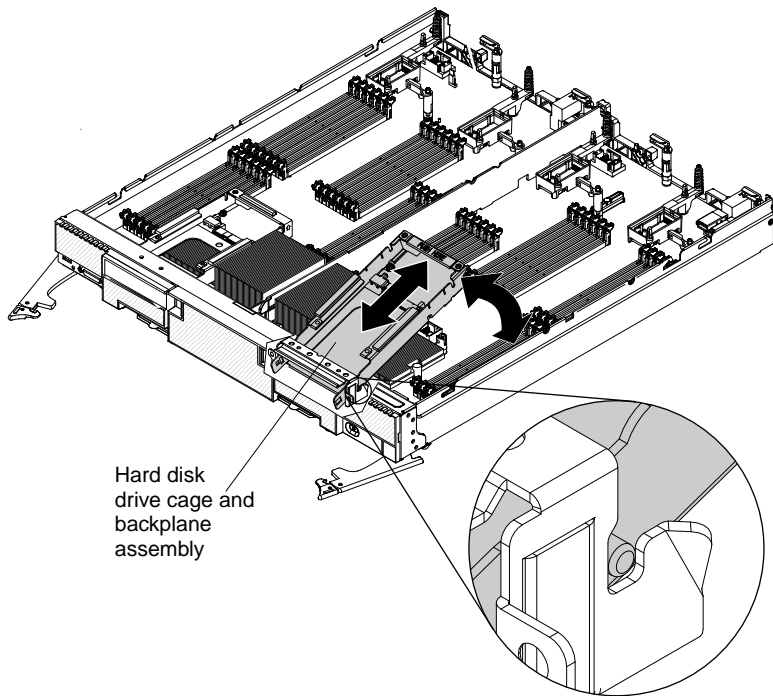
- Step 1. Remove the cover (see “Removing the compute node cover” on page 885).
- Step 2. Position the assembly in the drive bay at an angle and rotate the assembly into the connector on the system board.
- Step 3. Press the assembly firmly into the system board connector.
- Step 4. Insert the hot-swap hard disk drives and hard disk drive bay fillers (see “Installing a hot-swap hard disk drive” on page 909).

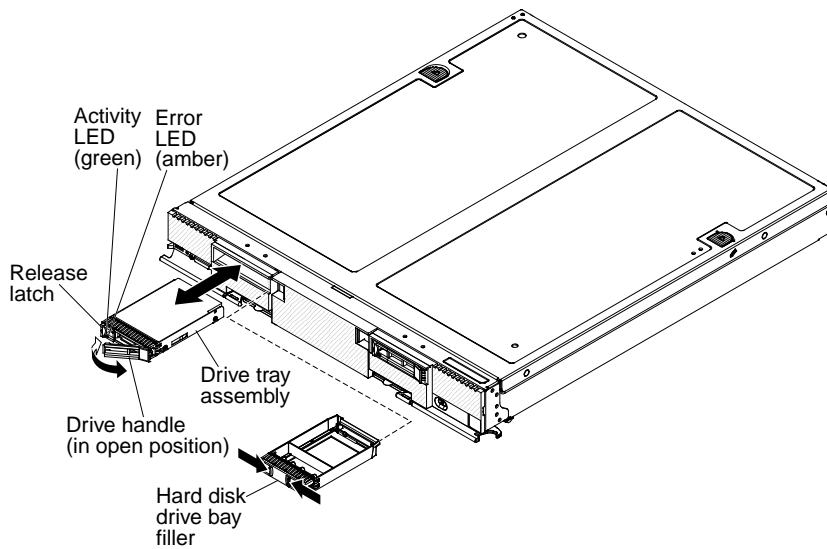
Step 1. Press the release latch (orange) on the hard disk drive to release the drive handle.

Step 2. Pull the release handle to remove the drive from the bay.
