Lenovo Flex System x280 X6, x480 X6, and x880 X6 Compute Node Installation and Service Guide

Machine Types: 7196, 4258

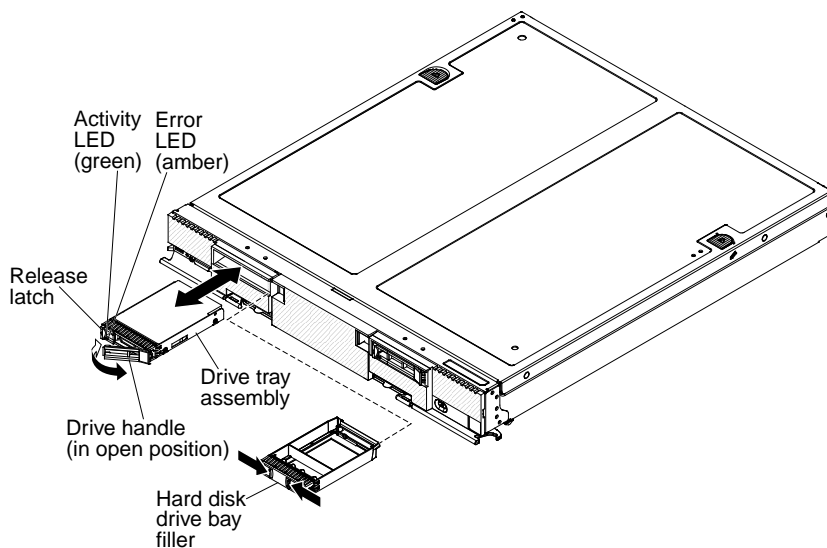
- Step 1. Identify the hard disk drive bay (hard disk drive bay 0 or hard disk drive bay 1) in which you plan to install the hot-swap hard disk drive.
- Step 2. If a hard disk drive bay filler is installed, remove it from the compute node by pressing together the release latches and sliding the filler away from the compute node.

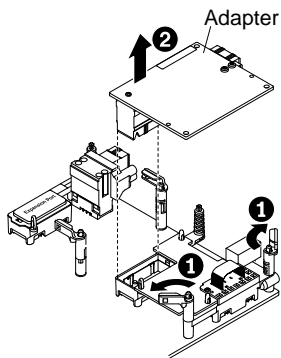
- Step 1. Remove the cover (see “Removing the compute node cover” on page 885).
- Step 2. Locate the I/O expansion adapter connectors (see “System-board layouts” on page 19).
- Step 3. Open the retention clips **1**.
- Step 4. Lift the I/O expansion adapter from the connector and remove the I/O expansion adapter from the compute node **2**. You might find it helpful to rock the adapter back and forth to disengage the adapter.

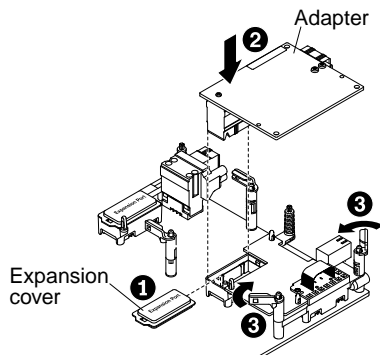
- Step 1. Remove the cover (see “Removing the compute node cover” on page 885).
- Step 2. Locate the I/O expansion connectors (see “System-board connectors” on page 19).

- Step 3. Remove the expansion cover 1 from the connector, if one is present.
- Step 4. Touch the static-protective package that contains the adapter to any *unpainted* metal surface on the Lenovo Flex System chassis or any *unpainted* metal surface on any other grounded rack component; then, remove the adapter from the package.

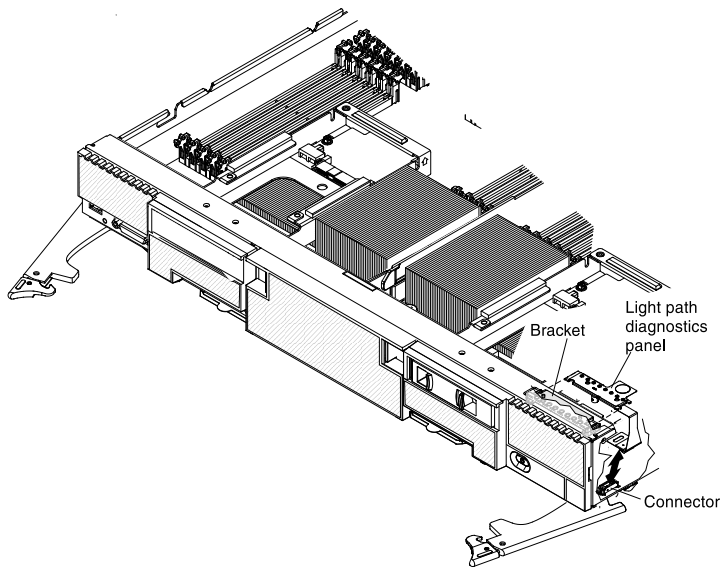
- Step 1. Remove the cover (see “Removing the compute node cover” on page 885).
- Step 2. Pull the light path diagnostics panel out of the bracket.
- Step 3. Disconnect the cable from the system board.
- Step 4. Lift the light path diagnostics panel from the compute node.

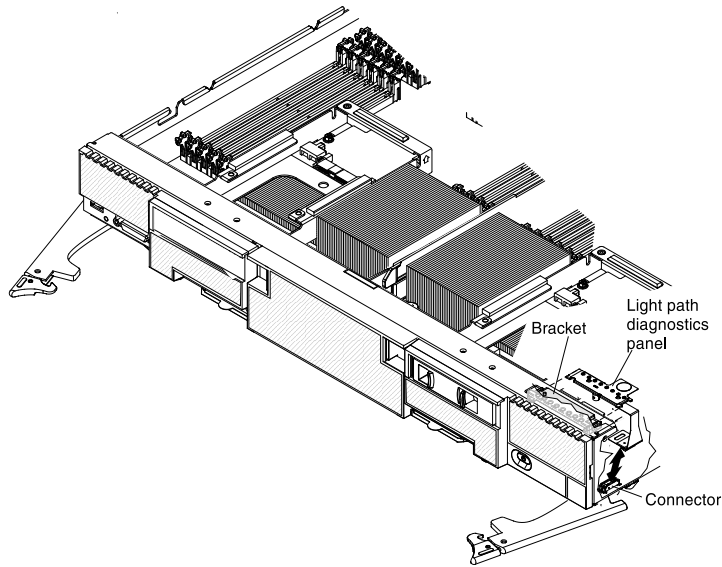
- Step 1. Remove the cover (see “Removing the compute node cover” on page 885).
- Step 2. Connect the cable on the system board.
- Step 3. Align the light path diagnostics panel with the bracket.
- Step 4. Press the light path diagnostics panel securely in the bracket.

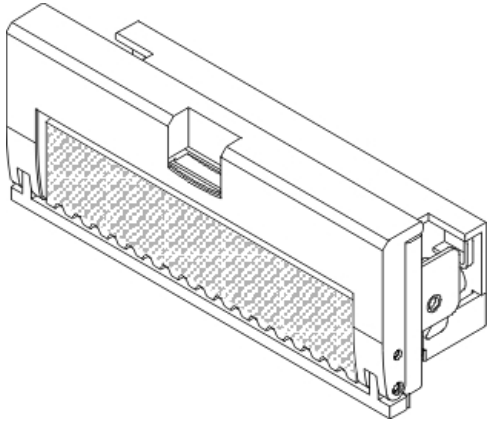
- Flex System X6 2-Socket Performance Accelerator

Important: The single compute node must have E7-4800v3 microprocessors, or E7-8800v3 microprocessors to support the two-socket performance connector.

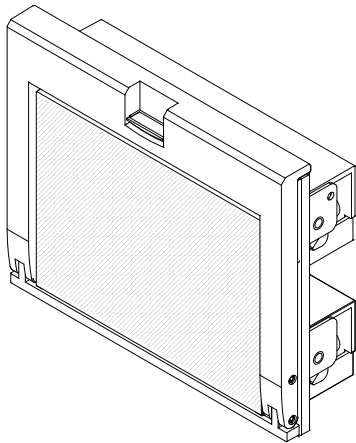
- Flex System X6 4-Socket Scalability Connector

Important: The compute nodes must have Intel Xeon E7-4800v3 microprocessors or E7-8800v3 microprocessors to form a two-node (four-socket) complex.

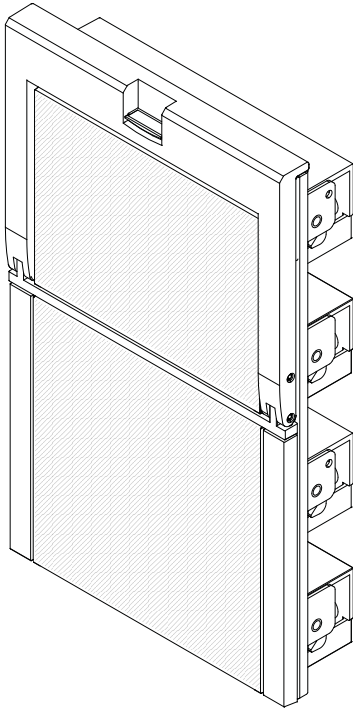
- Flex System X6 8-Socket Scalability Connector

Important: The compute nodes must have Intel Xeon E7-8800v3 microprocessors to form a four-node (eight-socket) complex.

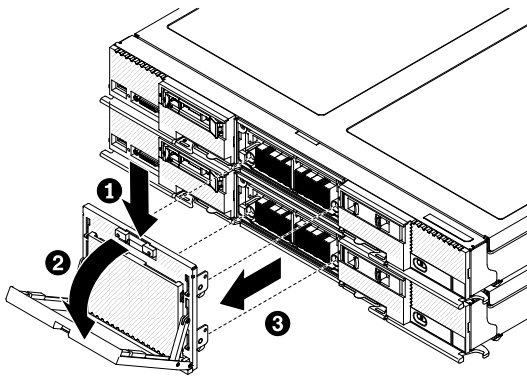
Step 1. Press the blue release button to release the handle and disengage the scalability and performance connector from the compute node.

Step 2. Grip the handle and pull the scalability and performance connector from the compute node.

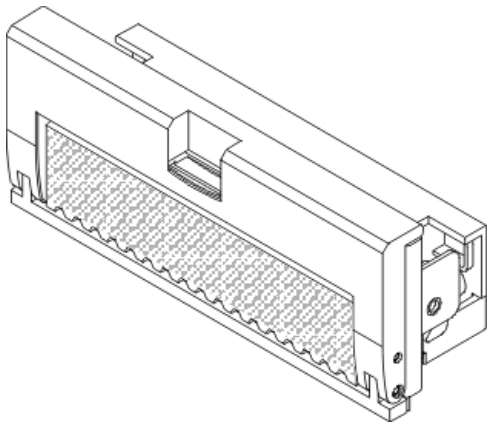
- Flex System X6 2-Socket Performance Accelerator

Important: The compute node must have Intel Xeon E7-4800v3 microprocessors, or E7-8800v3 microprocessors to support the two-socket performance connector.

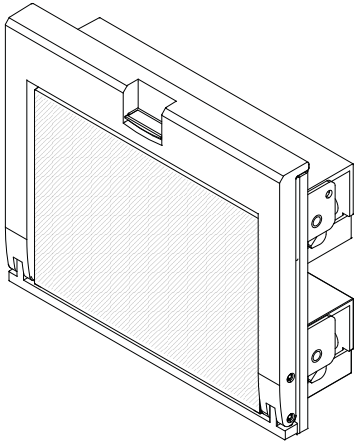
- Flex System X6 4-Socket Scalability Connector

Important: The compute nodes must have Intel Xeon E7-4800v3 microprocessors or E7-8800v3 microprocessors to form a two-node (four-socket) complex.

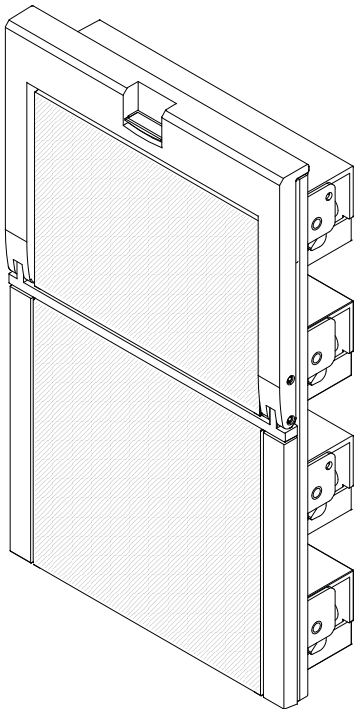
- Flex System X6 8-Socket Scalability Connector

Important: The compute nodes must have Intel Xeon E7-8800v3 microprocessors to form a four-node (eight-socket) complex.

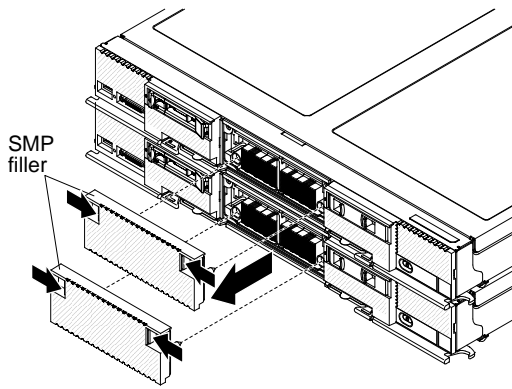
Step 1. Remove the SMP filler from the compute node, if one is present.

Step 2. Remove the protective covers from the connectors on the scalability and performance connector.

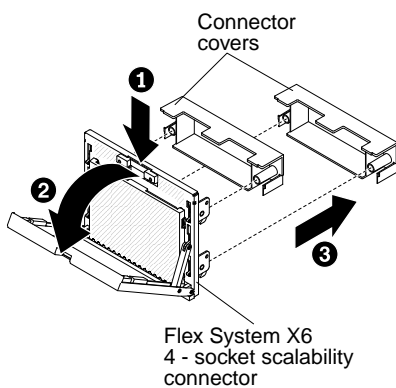
Step 3. Press the blue release button to release the handle and rotate the handle to the fully open position.

Step 4. Align the guide pins on the scalability and performance connector with the guide pin sockets on the compute node and press the connector against the compute node.

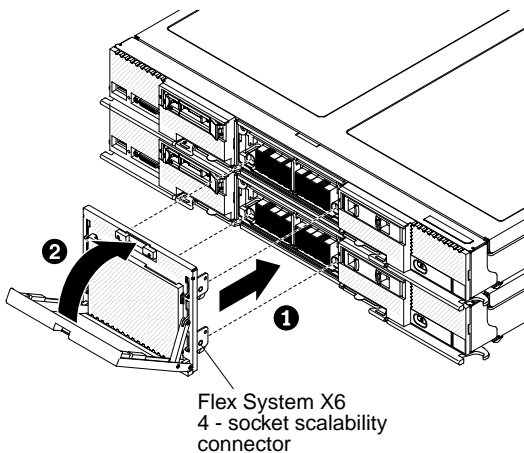
Note: Make sure that the handle is in the open position to engage the connector with the compute node.

Step 5. Press the handle against the assembly to lock the assembly against the compute node.

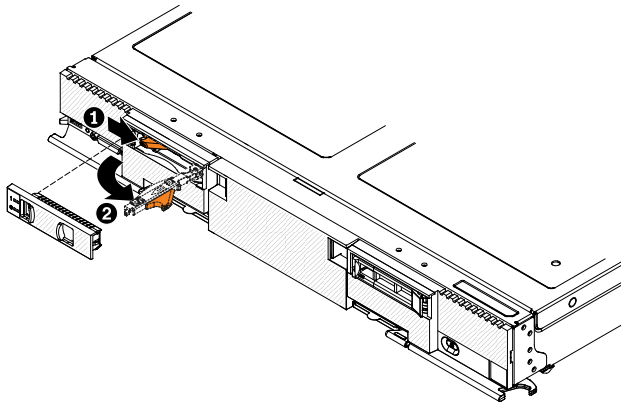
Step 2. For the solid state drive that you want to remove, press the release latch and rotate the loose end of the retention lever away from the compute node.

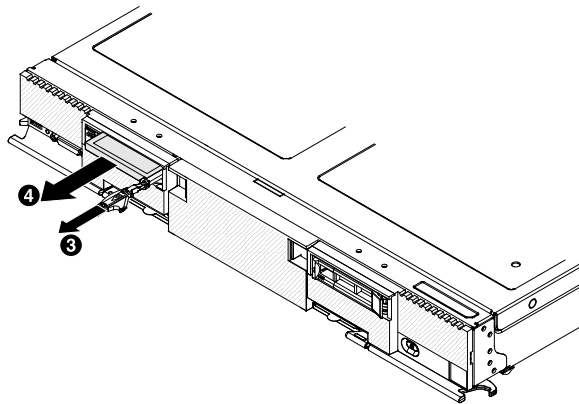
Step 3. Pull the retention lever toward you to slide the solid state drive out of the slot.

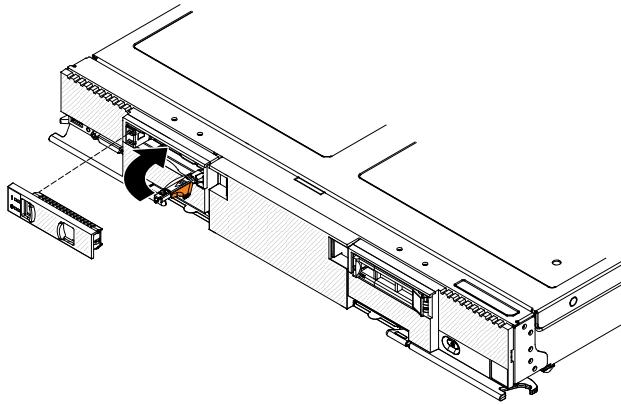
Step 4. Close the retention lever and secure it with the latch.

Note: You might have to press the latch before you close the retention lever.

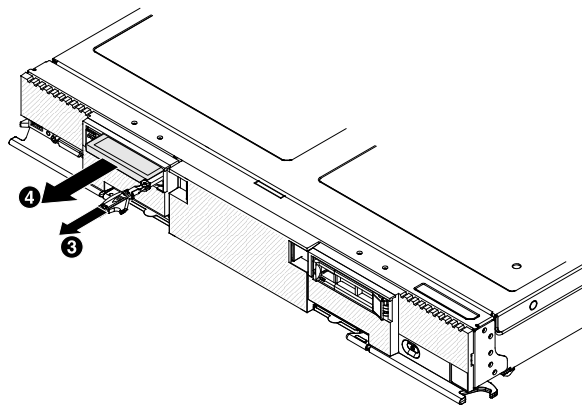
- Step 1. Touch the static-protective package that contains the solid state drive to any *unpainted* metal surface on the chassis or any *unpainted* metal surface on any other grounded rack component; then, remove the solid state drive from the package.
- Step 2. Slide the solid state drive into the slot until it is firmly seated in the connector.

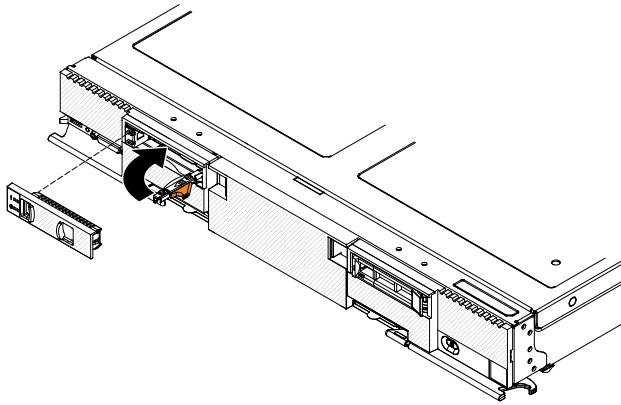
- Step 3. If you have a second solid state drive to install, repeat steps Step 1 2 on page 920 through Step 2 3 on page 920.
- Step 4. Close the retention lever and secure it with the latch.

Note: You might have to press the latch before you close the retention lever.

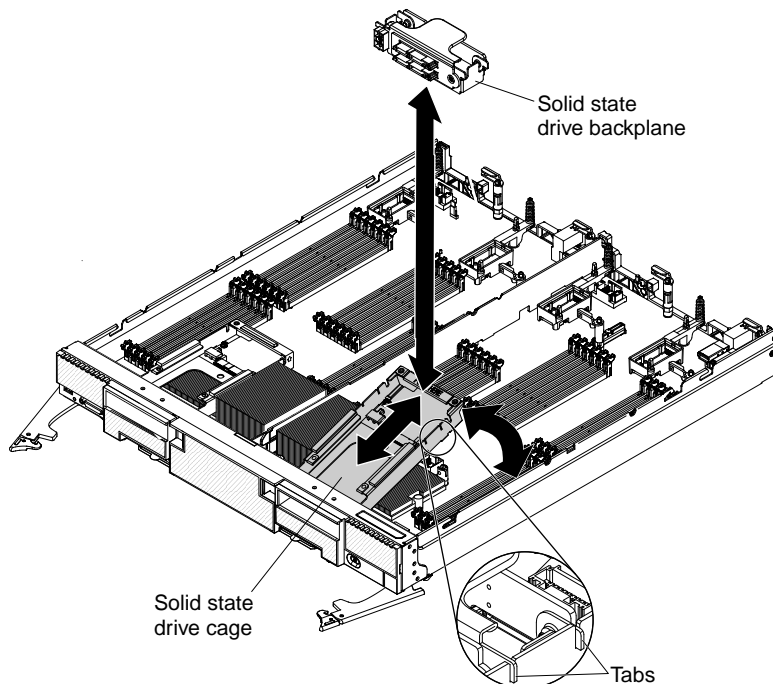
- Step 1. Remove the cover (see “Removing the compute node cover” on page 885).
- Step 2. Remove the solid state drive bezel.
- Step 3. Remove the solid state drives (see “Removing a solid state drive” on page 919).
- Step 4. Pull the solid state drive backplane from the cage.
- Step 5. Remove the solid state drive mounting sleeve (see “Removing the solid state drive mounting sleeve” on page 923).
- Step 6. Lift up on the rear of the cage to disconnect it from the connector on the system board.
- Step 7. Remove the cage from the compute node at an angle.

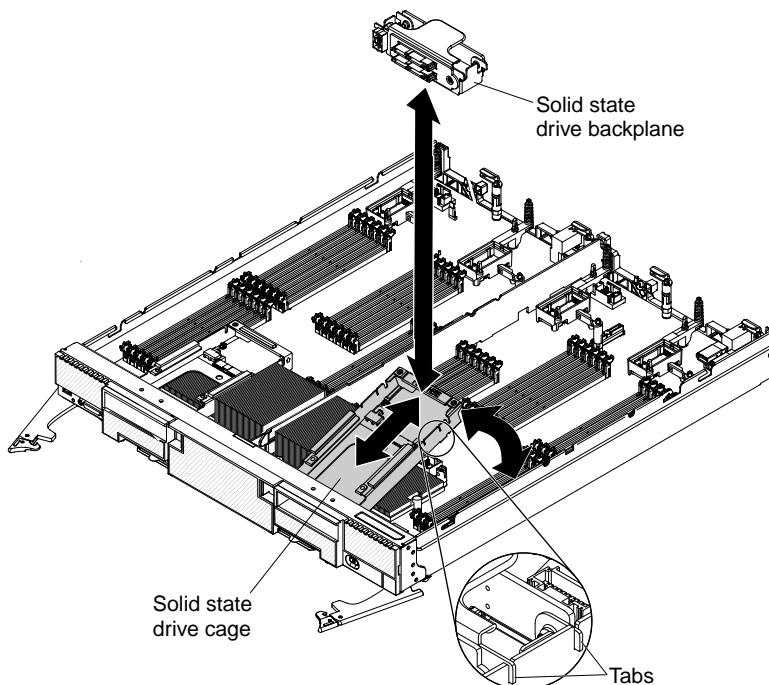
- Step 2. Remove the solid state drive mounting sleeve (see “Removing the solid state drive mounting sleeve” on page 923).
- Step 3. Position the cage in the drive bay at an angle and rotate the cage into the connector on the system board and make sure it is firmly seated in the connector.
- Step 4. Press the solid state drive backplane into the solid state drive cage and make sure it is firmly seated in the connector and that the tabs are firmly seated in the cage.
- Step 5. Install the solid state drive mounting sleeve (see “Installing the solid state drive mounting sleeve” on page 924).
- Step 6. Install the solid state drives (see “Installing a solid state drive” on page 920).
- Step 7. Install the solid state drive bezel.

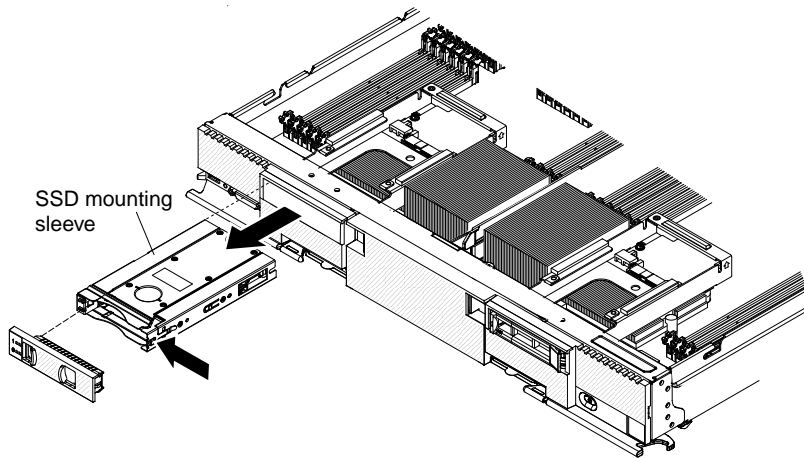
- Step 1. Remove the solid state drive bezel.
- Step 2. Remove the solid state drives (see “Removing a solid state drive” on page 919).
- Step 3. Gently pry open the release latch on the right side of the SSD mounting sleeve.
- Step 4. Slide the SSD mounting sleeve out of the compute node.

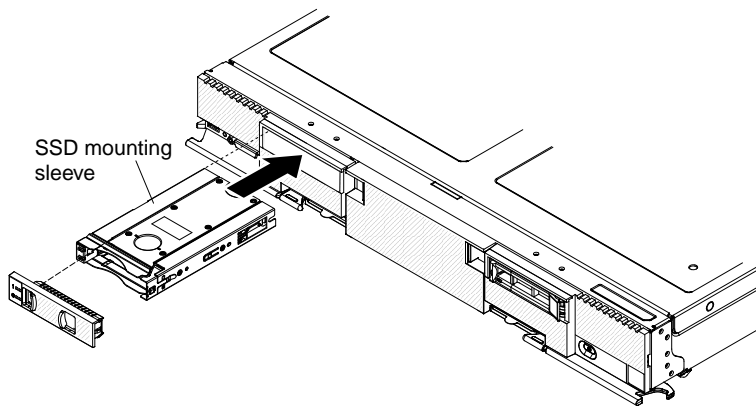
- Step 1. If necessary, remove the SSD bezel.
- Step 2. Slide the SSD mounting sleeve in the compute node until the release latch snaps to secure the sleeve.
- Step 3. Replace the SSDs in the SSD mounting sleeve (see “Installing a solid state drive” on page 920).
- Step 4. Replace the SSD bezel.

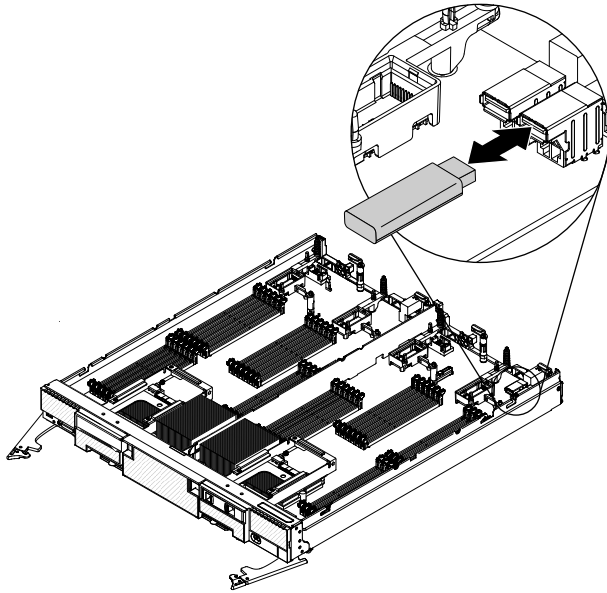
Step 1. Remove the cover (see “Removing the compute node cover” on page 885).

Step 2. Locate the USB connectors on the system board.

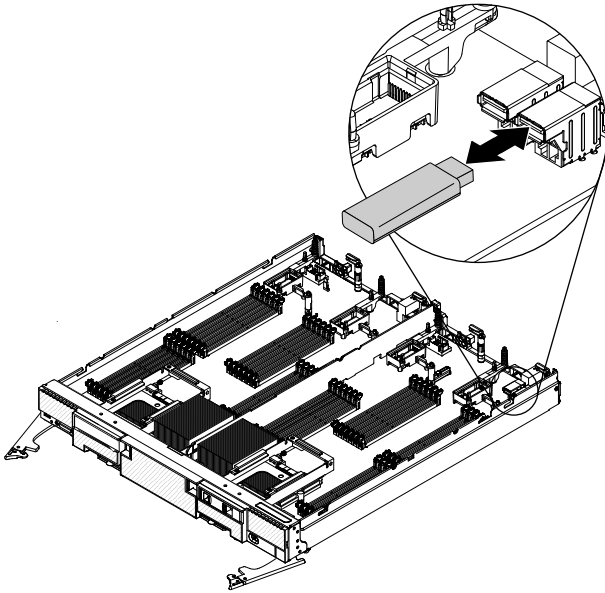
Step 1. Remove the cover (see “Removing the compute node cover” on page 885).

Step 2. Locate the USB connectors on the system board.

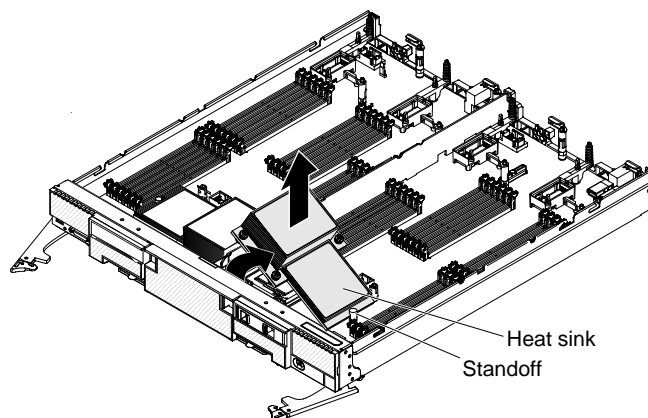
- a. Use a screwdriver to loosen the screw on one side of the heat sink to break the seal with the microprocessor.
- b. Use a screwdriver to loosen the screws on the heat sink, rotating each screw two full turns until each screw is loose.

- c. Gently pull the heat sink from the microprocessor and pivot the heat sink from the standoff.

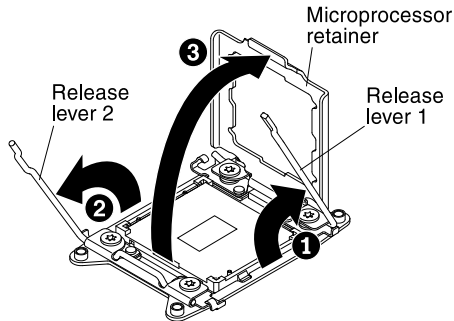
Step 9. Open the microprocessor socket release levers and retainer.

- a. Identify which release lever is labeled as the first release lever to open, and open it.
- b. Open the second release lever on the microprocessor socket.
- c. Open the microprocessor retainer.

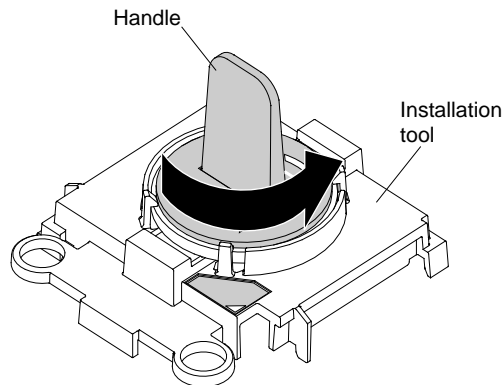
- a. Twist the handle on the microprocessor tool counterclockwise so that it is in the open position.

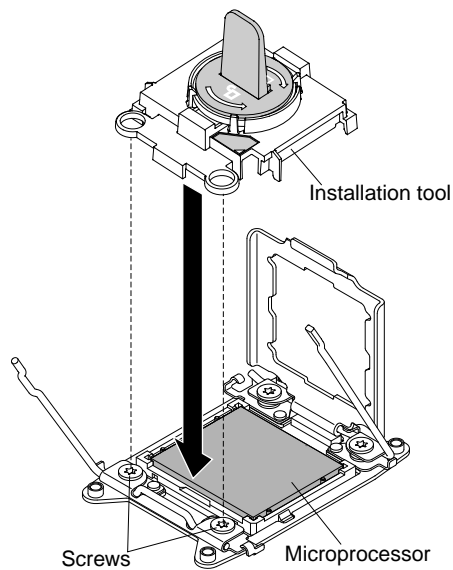
- b. Align the installation tool with the screws on the microprocessor socket, and lower the tool on the microprocessor. The installation tool rests flush on the socket only if it is aligned correctly.

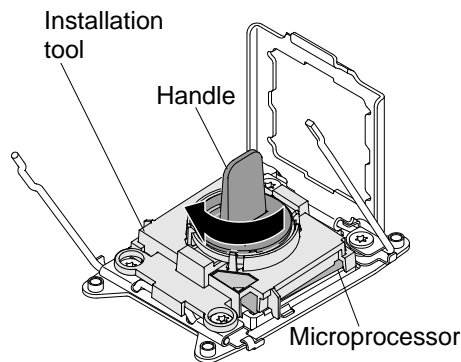
- c. Twist the handle on the installation tool clockwise and lift the microprocessor out of the socket.

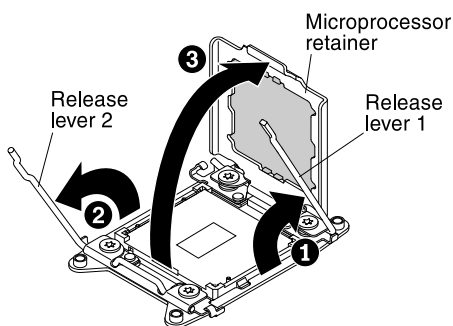
- Step 8. Open the microprocessor socket release levers and retainer.

- a. Identify which release lever is labeled as the first release lever to open and open it.

- b. Open the second release lever on the microprocessor socket.
- c. Open the microprocessor retainer.

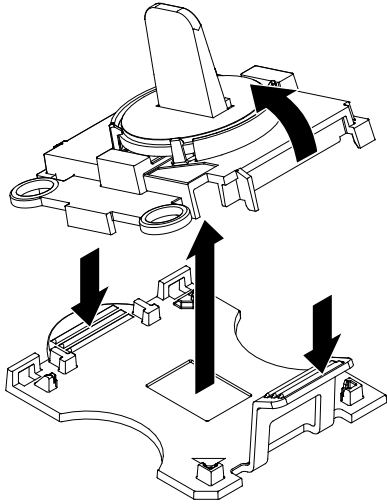
- a. Open the packaging that contains the new microprocessor installation tool assembly and carefully remove the installation tool assembly from the package.

Note: Do not touch the microprocessor contacts. Contaminants on the microprocessor contacts, such as oil from your skin, can cause connection failures between the contacts and the socket.

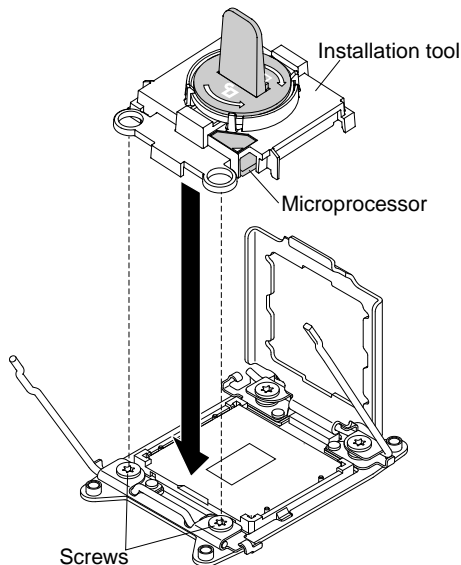
- b. Remove the microprocessor protective cover if one is present.
- c. Align the installation tool with the microprocessor socket. The installation tool rests flush on the socket only if it is properly aligned.

- d. Twist the handle on the microprocessor tool counterclockwise to insert the microprocessor into the socket. The microprocessor is keyed to ensure that the microprocessor is installed correctly.

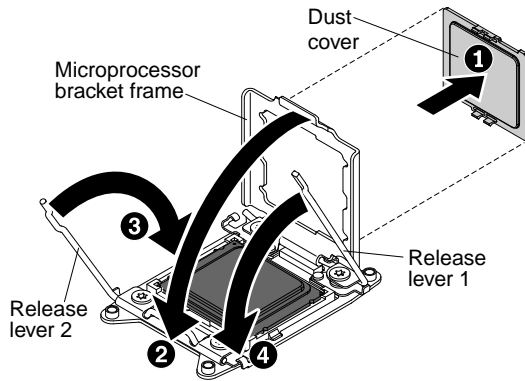
Step 10. Close the microprocessor retainer and release levers in the order that is shown.

- Remove the microprocessor dust cover.
- Close the microprocessor retainer on the microprocessor socket.
- Identify which release lever is labeled as the first release lever to close, and close it.
- Close the second release lever on the microprocessor socket.

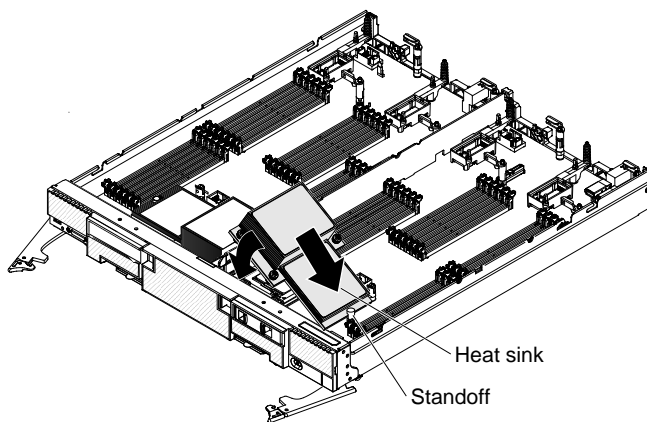
Step 11. If you are installing a new heat sink, remove the plastic protective cover from the bottom of the heat sink. If you are reinstalling a heat sink that you previously removed from the compute node, make sure that the thermal grease is still on the bottom of the heat sink and on the top of the microprocessor.

- Position the notched side of the heat sink in the standoff and align the heat sink over the microprocessor. The heat sink is keyed to assist with proper alignment.

- b. Align and place the heat sink on top of the microprocessor in the retention bracket, thermal grease side down.
- c. Align the screws on the heat sink with the holes on the heat-sink retention module.
- d. Press firmly on the heat sink.
- e. Press firmly on the captive screws and tighten them with a screwdriver, alternating between the screws in a figure-eight pattern, turn each screw one full rotation. You can cause damage to the microprocessor if you tighten the screws on one side first, rather than alternating sides. Each screw should then be tightened two more full rotations. Do not overtighten the screws with excessive force.

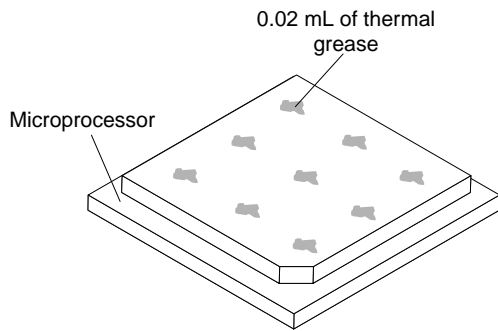
Step 4. Use a clean area of the cleaning pad to wipe the thermal grease from the microprocessor; then, dispose of the cleaning pad after all of the thermal grease is removed.

Step 5. Use the thermal-grease syringe to place nine uniformly spaced dots of 0.02 mL each on the top of the microprocessor.

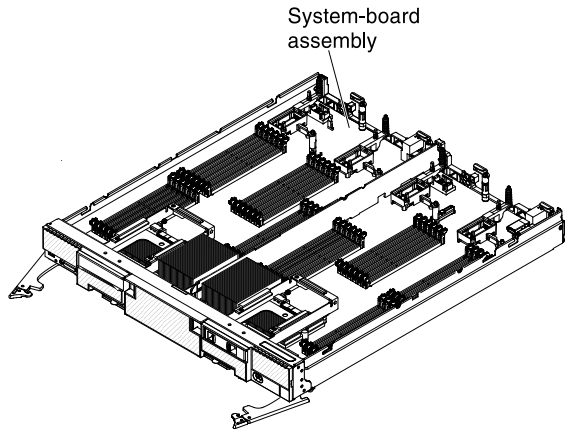
To remove the components from the system-board assembly, complete the following steps:

Step 2. Remove all of the installed components in the following list from the system-board assembly; then, place them on a static-protective surface or install them on the new system-board assembly.

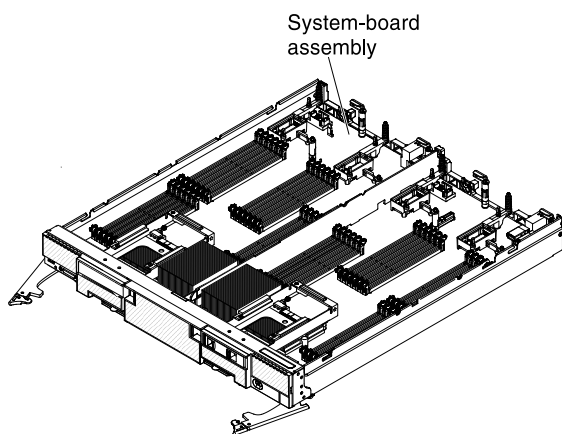
To install the components on the system-board assembly, complete the following steps.

- Step 1. Install all of the components in the following list that you removed from the old system-board assembly onto the new system-board assembly.
- Center partition (see “Installing the center partition” on page 880).
