## Lenovo Flex System x240 M5 Compute Node Installation and Service Guide

Machine Types: 9532, 2591

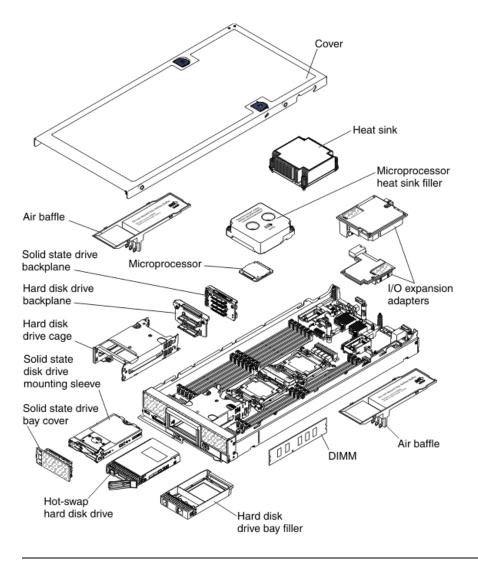
The following illustration shows the major components of the compute node.

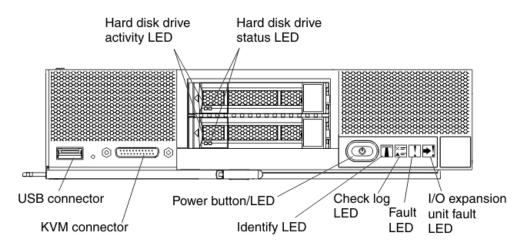
The following illustration identifies the buttons, connectors, and LEDs on the control panel.

#### Power button/LED (green)

When the compute node is connected to power through the Lenovo Flex System chassis, press this button to turn on or turn off the compute node.

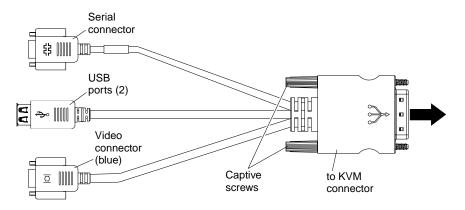
Use the console breakout cable to connect external I/O devices to the compute node. The console breakout cable connects through the KVM connector (see "Compute node controls, connectors, and LEDs" on page 12). The console breakout cable has connectors for a display device (video), two USB 2.0 connectors for a USB keyboard and mouse, and a serial interface connector.

The following illustration identifies the connectors and components on the console breakout cable.

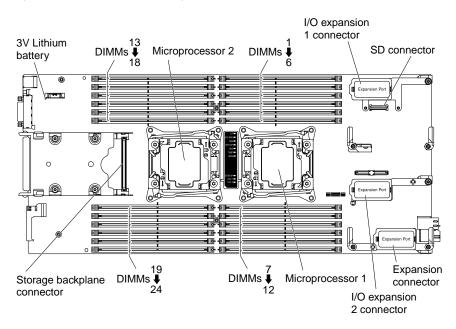
The following illustration shows the system-board components, including connectors for user-installable optional devices, in the compute node.

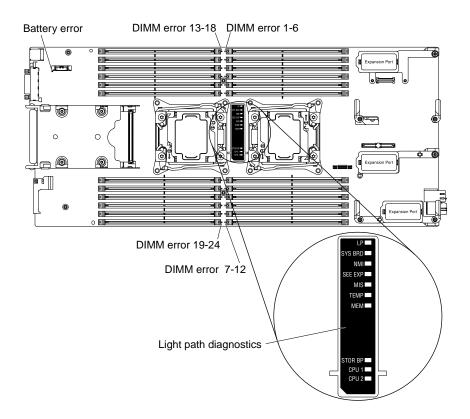
The following illustration shows the locations of the LEDs on the system board.

See "Light path diagnostics LEDs" on page 65 for information about how to interpret the system-board LEDs.

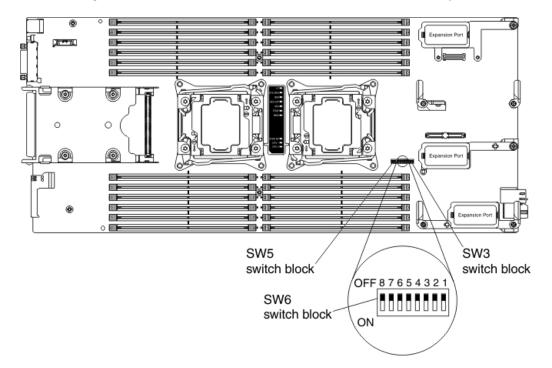
The following illustration shows the location of the switch blocks on the system board.

Note: Any system-board switches or jumpers that are not described in this section are reserved.

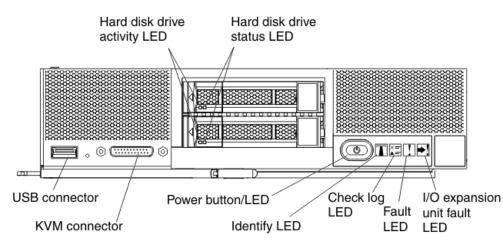
1. Look at the control panel on the front of the compute node.

- If the check log LED is lit, it indicates that a condition that causes an event to log in the IMM event log has occurred.
- If the fault LED is lit, it indicates that an error has occurred; view the light path diagnostics panel and LEDs to isolate the failing component.

- If the I/O expansion unit fault LED is lit, it indicates that an error has occurred in an I/O expansion unit that is installed in the compute node; check the IMM or CMM event log and the light path diagnostics LEDs to isolate the failing component.

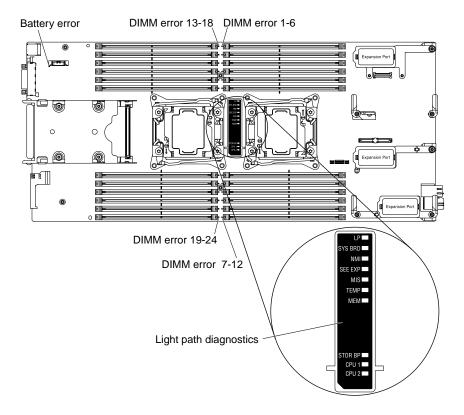
The following illustration shows the locations of the light path diagnostics LEDs on the system board.

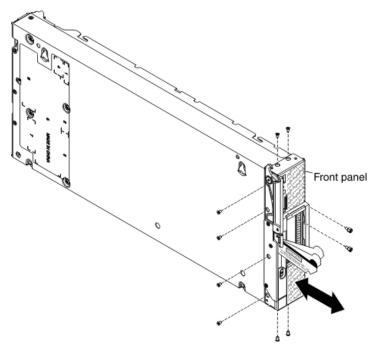
To remove the front panel, complete the following steps.

Step 1. If you are replacing the front panel, remove the ID label plate that has machine type and serial number information from the front panel and set it aside (see "Removing the ID label plate" on page 709).

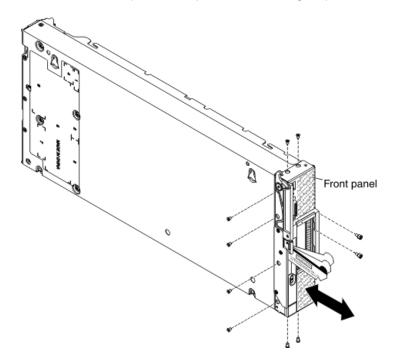
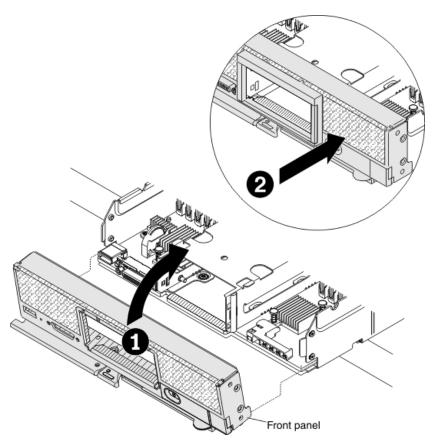
To install the front panel, complete the following steps.

- Step 2. With the front edge of the compute node protruding slightly past the edge of the work surface, align the bottom edge of the front panel with the front of the compute node chassis; then, carefully rotate the front panel into place on the compute node.

- Step 3. Using a T8 Torx screwdriver, install the two screws that secure the front panel to each side of the compute node chassis (four screws, total).

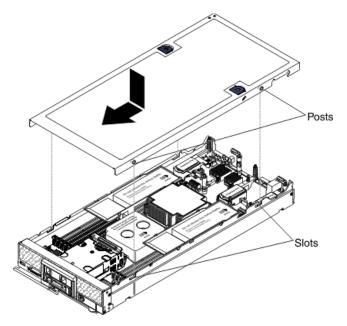
- Step 1. Carefully lay the compute node on a flat, static-protective surface, orienting the compute node with the bezel pointing toward you.
- Step 2. Orient the cover so that the posts on the inside of the cover slide into the slots on the compute node.

- Step 3. Hold the front of the compute node and slide the cover forward to the closed position, until it clicks into place.
- Step 4. To install a system service label, align the label on the cover, remove the backing, and press the label on the cover.

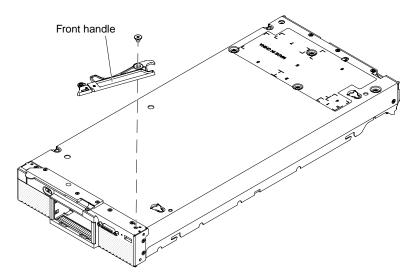
To remove the front handle, complete the following steps.

- Step 1. Locate the screw that attaches the handle to the compute node.
- Step 2. Using a T15 Torx screwdriver, remove the screw from the front handle and save the screw in a safe place. Use the same screw when you install a front handle.

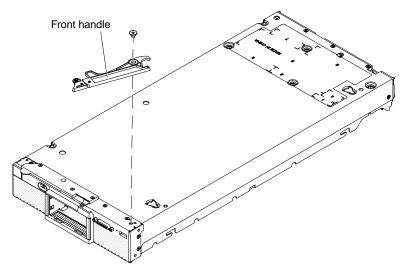
To install the front handle, complete the following steps.

- Step 1. Orient the front handle so that the blue release latch is toward the middle of the compute node.
- Step 2. Align the hole in the handle with the hole on the compute node where the handle is installed.
- Step 3. Using a T15 Torx screwdriver, install the screw that secures the handle. Install the screw that you removed when you removed the handle.

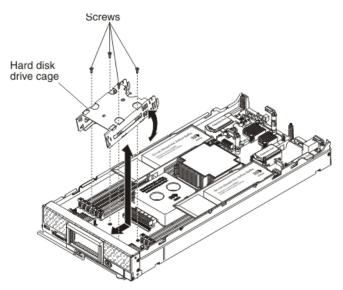
To remove the hard disk drive cage, complete the following steps.

- Step 1. Remove the cover (see "Removing the compute node cover" on page 699).
- Step 2. Remove storage drives, optional drive components, and hard disk drive bay fillers. See "Removing a hot-swap hard disk drive" on page 726, "Removing a 1.8-inch solid state drive" on page 730, or "Removing a solid state drive mounting sleeve" on page 727.
- Step 3. Remove the hard disk drive backplane (see "Removing a hard disk drive backplane" on page 724).
- Step 4. Using a T10 Torx screwdriver, remove the four screws from the cage and rotate the cage from under the compute node front panel; then, remove the cage from the compute node at an angle.

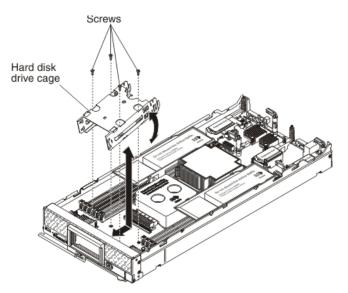
To install the hard disk drive cage, complete the following steps.

- Step 1. Remove the cover (see "Removing the compute node cover" on page 699).
- Step 2. Position the cage in the compute node front panel at an angle and rotate the cage into position on the system board.
- Step 3. Align the cage with the screw holes on the system board.
- Step 4. Using a T10 Torx screwdriver, insert the four screws and secure the cage in the compute node.
- Step 5. Install the hard disk drive backplane (see "Installing a hard disk drive backplane" on page 725).
- Step 6. Insert the storage drives, optional drive components, and hard disk drive bay fillers. See "Installing a hot-swap hard disk drive" on page 726, "Installing a solid state drive mounting sleeve" on page 729, or "Installing a 1.8-inch solid state drive" on page 732.

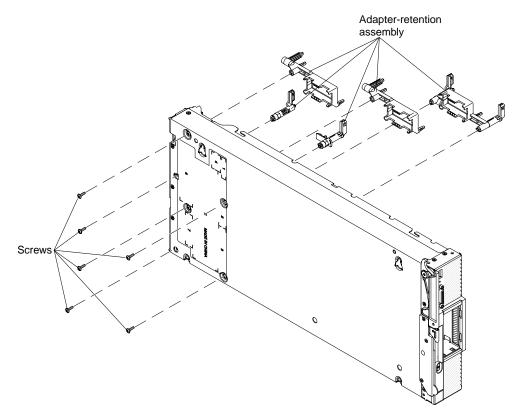
The adapter-retention assembly consists of five separate parts. You can replace only the parts that you choose and save the unused parts for future use.

To remove the adapter-retention assembly, complete the following steps.

- Step 1. Remove the cover (see "Removing the compute node cover" on page 699).
- Step 2. Remove the air baffles.
- Step 3. If necessary, remove the I/O expansion adapters and Adapter for SD Media (see "Removing an I/O expansion adapter" on page 740 and "Removing the SD Media Adapter for System x" on page 744).
- Step 4. Carefully place the chassis on its side with the front handle side up.
- Step 5. Using a T10 Torx screwdriver, remove the screws that secure each part of the adapter-retention assembly that you are removing.

**Note:** All adapter-attention assembly parts are shown. Replace the parts that are needed and save the unused parts for future use.

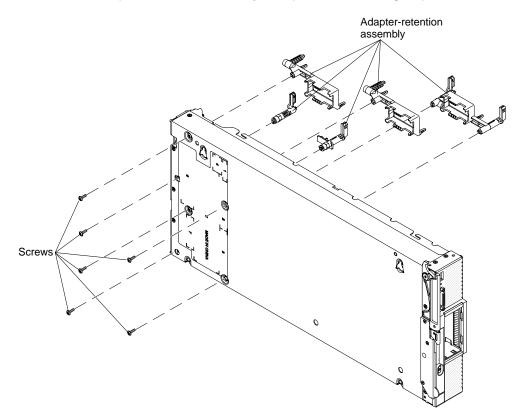
The adapter-retention assembly consists of five separate parts. You can replace only the parts that you choose and save the unused parts for future use.

To install the adapter-retention assembly, complete the following steps.

- Step 1. Remove the cover (see "Removing the compute node cover" on page 699).
- Step 2. Remove the air baffles.
- Step 3. Carefully place the chassis on its side with the front handle side up.
- Step 4. Align each part of the adapter-retention assembly on the system board.

**Note:** All adapter-attention assembly parts are shown. Replace the parts that are needed and save the unused parts for future use.

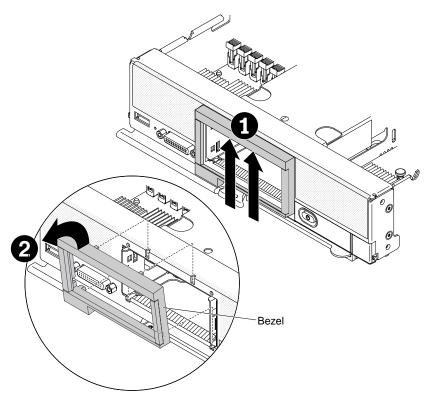
To remove the bezel, complete the following steps.

- Step 1. If any hard disk drives, fillers, or SSD sleeves are installed, remove them.
- Step 2. Press up on the inside top of the bezel; then, rotate the top edge of the bezel away from the compute node.
- Step 3. Lift the bezel from the compute node.

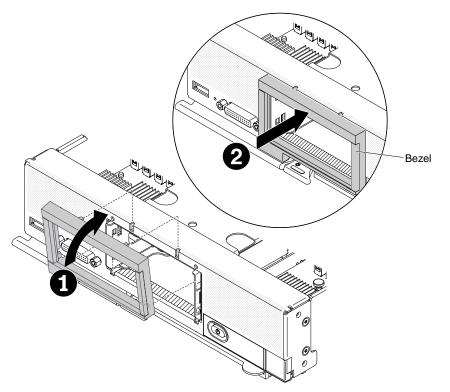
To install the bezel, complete the following steps.

- Step 1. Position the bezel on the front of the compute node.
- Step 2. Hook the bottom edge of the bezel on the front of the compute node; then, rotate the top of the bezel toward the chassis.
- Step 3. Press the bezel securely against the chassis.

**Note:** Make sure that the bezel is pressed flat against the chassis. Lifting up slightly on the top edge of the bezel as you press it might make it easier to seat the clips.

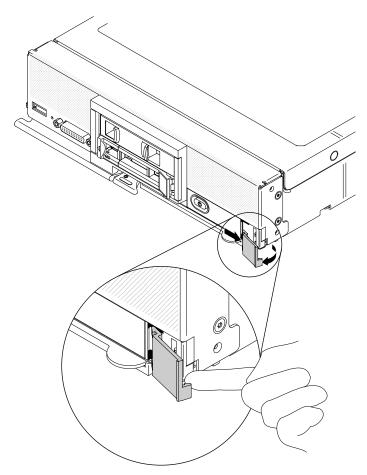
To remove the ID label plate, complete the following steps.

- Step 1. Using a finger nail or flat-blade screwdriver under the lower outside corner of the label plate, pull the outer edge of the ID label plate away from the compute node front panel.
- Step 2. Rotate the ID label plate away from the front panel; then, remove the ID label plate.

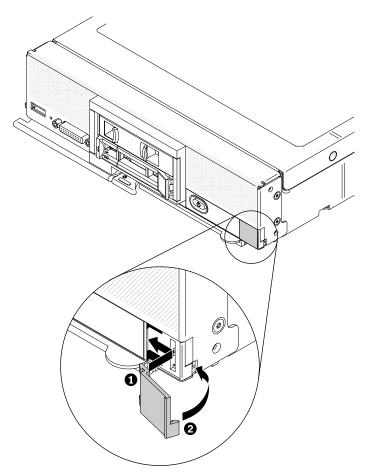
- Step 1. Place the clips on the ID label plate into the slots on the compute node front panel.
- Step 2. Rotate the outer edge of the ID label plate toward the compute node front panel; then, press the ID label plate securely against the front panel.

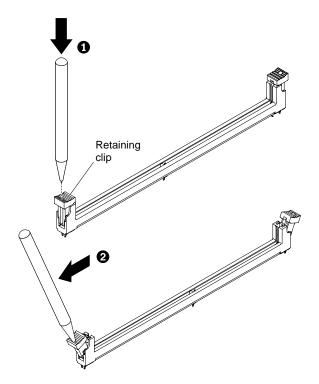
Step 4. Carefully open the retaining clips on each end of the DIMM connector.

**Note:** If necessary due to space constraints, you can use a pointed tool to open the retaining clips. Place the tip of the tool in the recess on the top of the retaining clip; then, carefully rotate the retaining clip away from the DIMM connector.

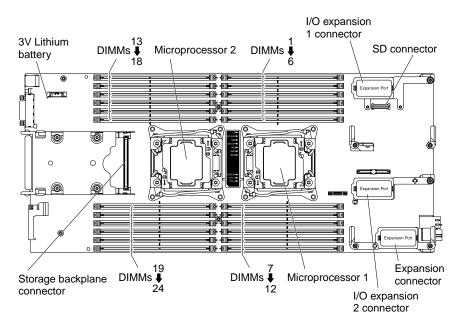
The following illustration shows the system-board components, including DIMM connectors.

The compute node has a total of 24 dual inline memory module (DIMM) connectors. The compute node supports low-profile (LP) DDR4 DIMMs with error-correcting code (ECC) in 4 GB, 8 GB, 16 GB, 32 GB and 64 GB capacity.

The memory is accessed internally through four channels. Each memory channel has three DIMM connectors for each microprocessor (six total). Each channel can have a maximum of eight ranks. The following table lists the memory channels and shows which DIMM connectors are in the channel for each microprocessor.

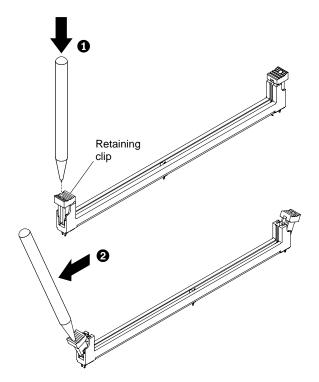
**Note:** If necessary due to space constraints, you can use a pointed tool to open the retaining clips. Place the tip of the tool in the recess on the top of the retaining clip; then, carefully rotate the retaining clip away from the DIMM connector.

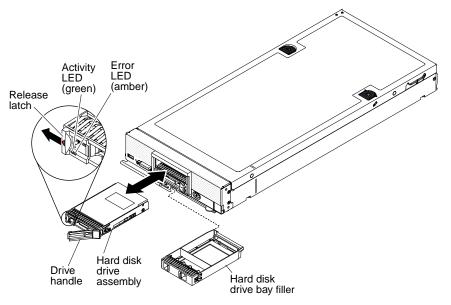
Step 1. Press the release latch (orange) on the hard disk drive to release the drive handle.

Step 2. Pull the release handle to remove the drive from the bay.

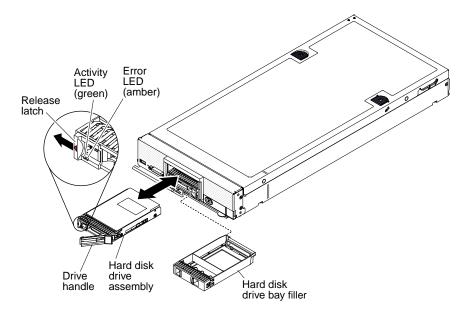
- Step 1. Identify the hard disk drive bay in which you plan to install the hot-swap hard disk drive.
- Step 2. If a hard disk drive bay filler is installed, remove it from the compute node by pulling the release lever and sliding the filler away from the compute node.
- Step 3. Touch the static-protective package that contains the hot-swap hard disk drive to any *unpainted* metal surface on the Lenovo Flex System chassis or any *unpainted* metal surface on any other grounded rack component; then, remove the hard disk drive from the package.
- Step 4. Open the release lever on the hot-swap hard disk drive and slide the drive into the bay until it is firmly seated in the connector.
- Step 5. Lock the hot-swap hard disk drive into place by closing the release lever.
- Step 6. Check the hard disk drive status LEDs to make sure that the hard disk drive is operating correctly.

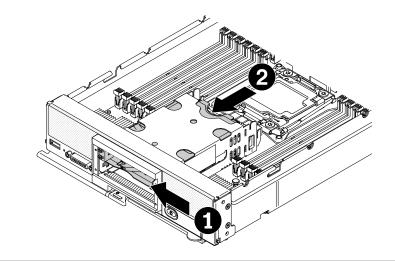
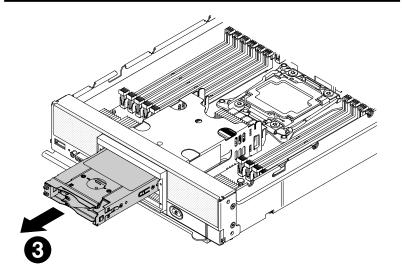
**Note:** There are two solid state drive mounting sleeves. The upper solid state drive mounting sleeve must be removed first.

- Step 1. Remove the compute node cover (see "Removing the compute node cover" on page 699).
- Step 2. Locate the solid state drive mounting sleeves on the compute node.

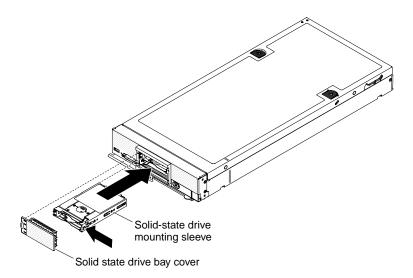
**Important:** Installation of a solid state drive mounting sleeve requires installation of a compatible solid-state drive backplane, bezel, and solid state drive bay cover.

- Step 1. Remove the compute node cover (see "Removing the compute node cover" on page 699).
- Step 2. Identify the hard disk drive bay in which you plan to install the solid state drive mounting sleeve.

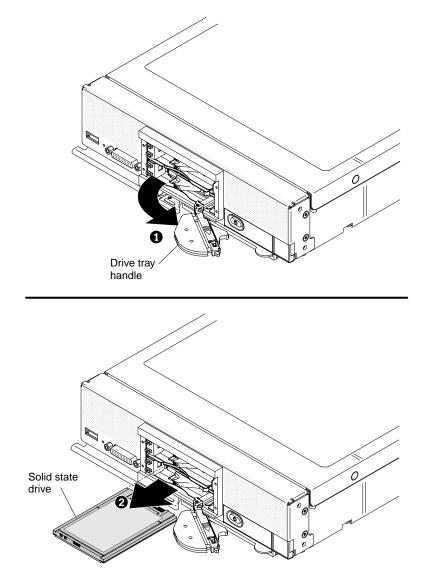
- Step 2. For the solid state drive that you want to remove, slide the release latch and rotate the loose end of the drive tray handle away from the compute node.
- Step 3. Pull forward on the drive tray handle to disengage the solid state drive; then, slide the solid state drive out of the drive bay.

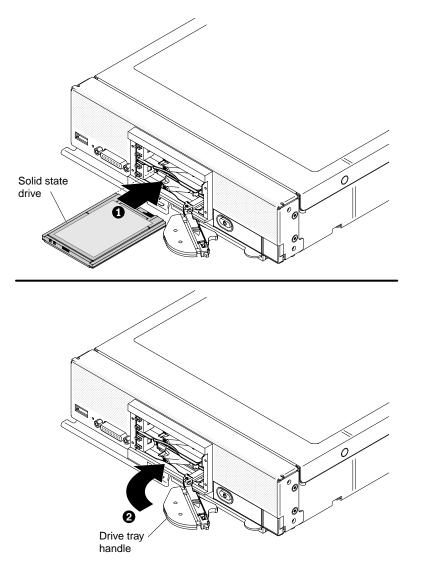
- Step 1. Remove the solid state drive bay cover.
- Step 2. For the solid state drive that you want to install, slide the release latch and rotate the loose end of the drive tray handle away from the compute node. Hook the recess on the drive tray handle on the tab on the right side of the solid state drive mounting sleeve to hold the drive tray handle in the open position.

- Step 3. Touch the static-protective package that contains the solid state drive to any *unpainted* metal surface on the chassis or any *unpainted* metal surface on any other grounded rack component; then, remove the solid state drive from the package.
- Step 4. Orient the solid state drive so that the label on the drive is facing up (solid state drive connector contacts are facing down).

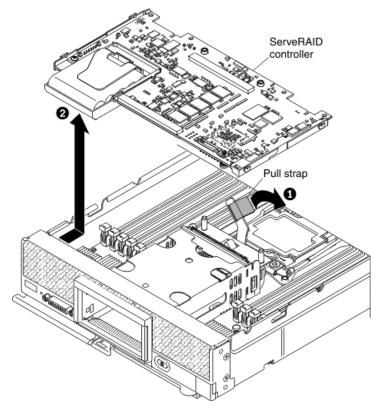
- a. Lift and rotate the lever on the hard disk drive backplane to disengage the ServeRAID controller from its connector.
- b. Lift the ServeRAID controller and remove it from the compute node.
- Step 5. Lift and remove ServeRAID hard disk drive backplane from the system-board assembly (see "Removing a hard disk drive backplane" on page 724).

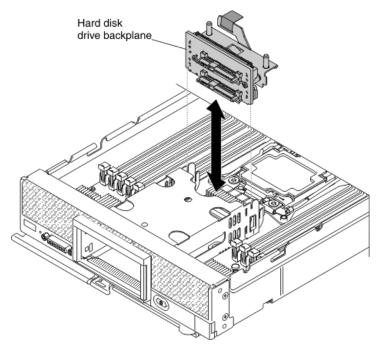
Step 3. If you are installing both the ServeRAID M5215 controller and hard disk drive backplane, install the ServeRAID M5215 hard disk drive backplane in the system-board assembly (see "Installing a hard disk drive backplane" on page 725). The ServeRAID M5215 controller hard disk drive backplane goes in the rear alignment slots on the hard disk drive cage.

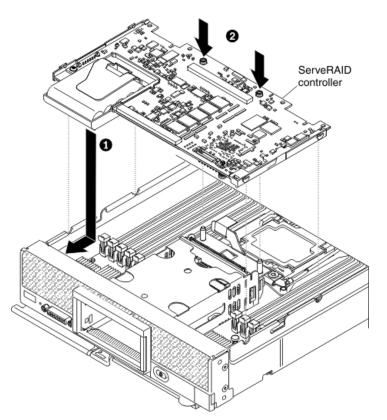
Step 7. Firmly press on the indicated locations to seat the ServeRAID controller.

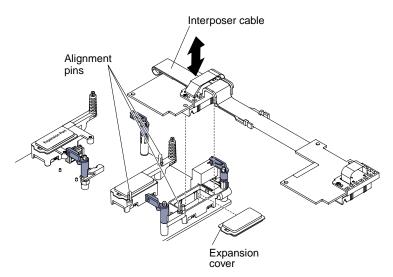
- Step 1. Remove the cover (see "Removing the compute node cover" on page 699).
- Step 2. Locate the interposer connector (see "System-board connectors" on page 18).
- Step 3. If an I/O expansion card is installed over the interposer connector, remove it (see "Removing an I/O expansion adapter" on page 740).
- Step 4. Lift the interposer cable from the connector and remove the cable from the compute node. You might find it helpful to rock the cable connector back and forth, from front to rear, to disengage the connector.

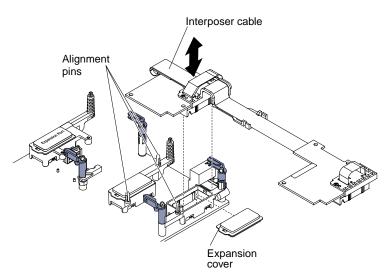
- Step 1. Remove the cover (see "Removing the compute node cover" on page 699).
- Step 2. Locate the interposer connector (see "System-board connectors" on page 18).

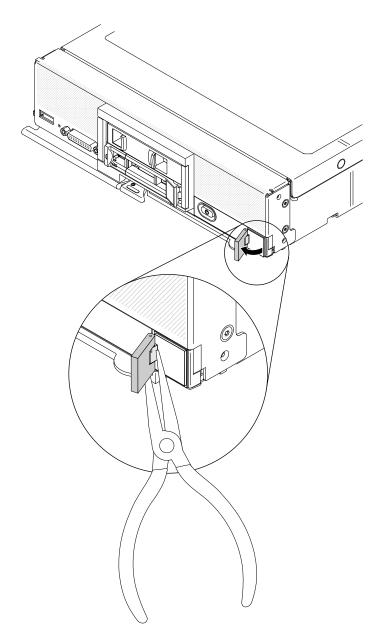
Step 1. If the RFID tag is still attached to its hinge, open the RFID tag.

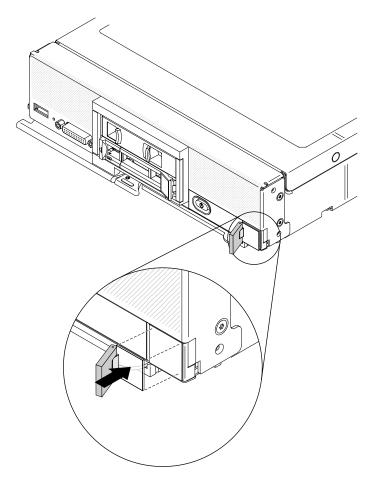
- Step 1. Make sure that the surface you are installing the tag on is thoroughly clean and dry.
- Step 2. Open the RFID tag; then, remove the backing from the base of the RFID tag to expose the adhesive.
- Step 3. Position the RFID tag over the ID label on the front panel of the compute node.
- Step 4. Press the RFID tag securely against the bezel and hold firmly in place for 30 seconds.

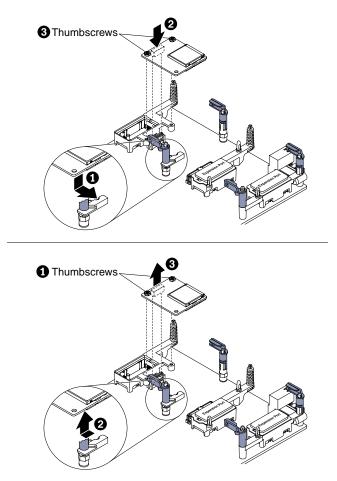
- Step 1. Remove the cover (see "Removing the compute node cover" on page 699).
- Step 2. If an I/O expansion adapter is installed over the Adapter for SD Media, remove it (see "Removing an I/O expansion adapter" on page 740).
- Step 3. Remove any SD cards that are installed in the Adapter for SD Media (see "Removing an SD card" on page 747).
- Step 4. Using a #1 Phillips screwdriver, loosen the two captive screws that secure the Adapter for SD Media.
- Step 5. Rotate the end of the Adapter for SD Media with the captive screws up; then, remove the adapter from the compute node.

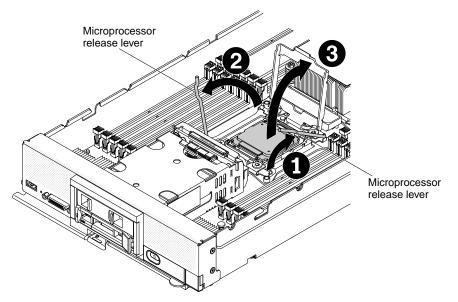
Step 4. Open the microprocessor socket release levers and retainer.

- a. Identify which release lever is labeled as the first release lever to open (labeled on the microprocessor-retention assembly) and open it.
- b. Open the second release lever on the microprocessor socket.
- c. Open the microprocessor retainer.

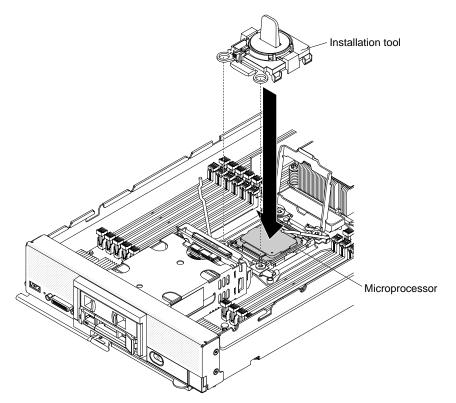
b. Align the installation tool with the screws, as shown in the following graphic, and lower the installation tool on the microprocessor. The installation tool rests flush on the socket only when it is aligned correctly.

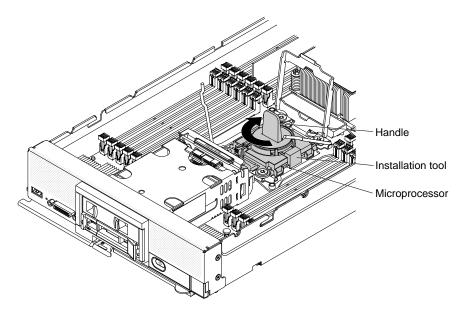
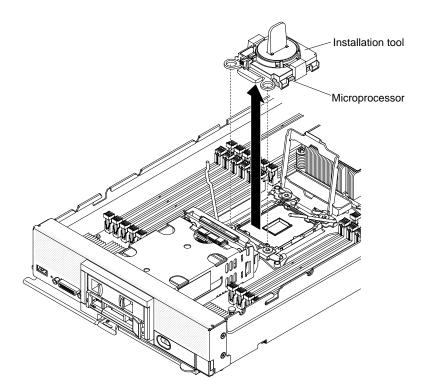
c. Gently twist the handle of the installation tool clockwise until it locks in the "H" or "L" position, depending on the size of microprocessor; then, lift the microprocessor out of the socket.

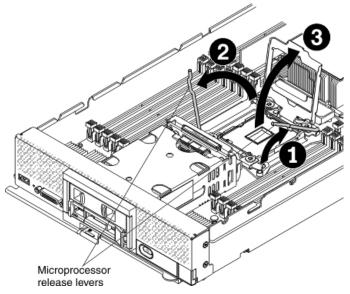
- a. Identify which release lever is labeled as the first release lever to open (labeled on the microprocessor-retention assembly) and open it.
- b. Open the second release lever on the microprocessor socket.
- c. Open the microprocessor retainer.
- Step 5. Install the microprocessor in the microprocessor socket.
  - a. Touch the static-protective package that contains the new microprocessor tool assembly with microprocessor to any *unpainted* on the compute node or any *unpainted* metal surface on any other grounded rack component.

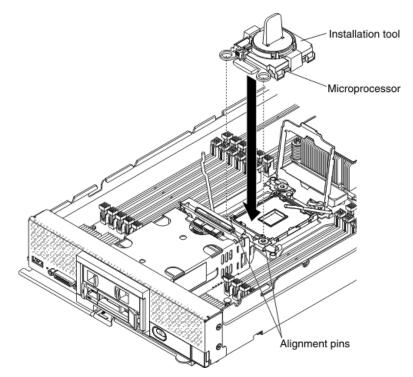
d. Align the installation tool with the microprocessor socket. The installation tool rests flush on the socket only if it is properly aligned.

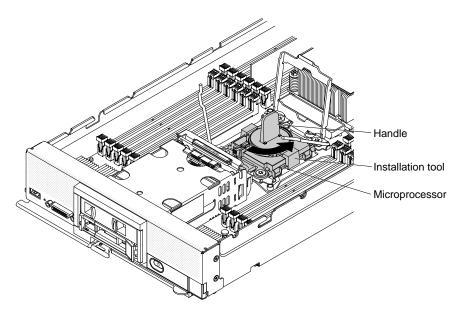
e. Twist the handle of the installation tool assembly counterclockwise until the microprocessor is inserted into the socket, and lift the installation tool out of the socket.

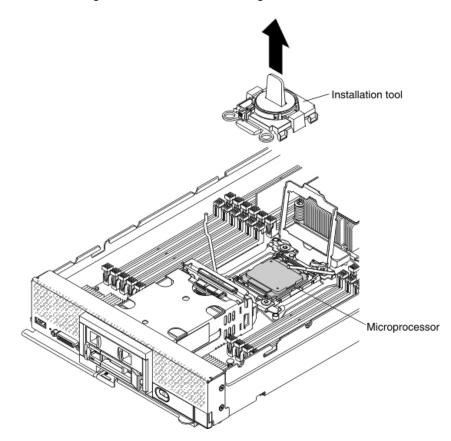
The following illustration shows removing the installation tool handle.

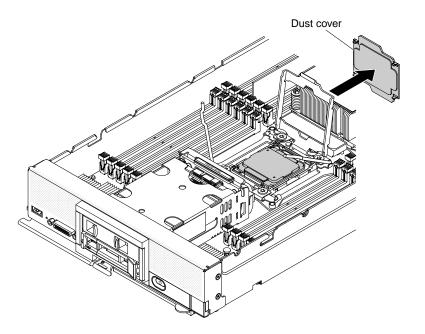
- Do not press the microprocessor into the socket.
- Do not touch the thermal grease on the bottom of the heat sink or on top of the microprocessor. Touching the thermal grease will contaminate it. If the thermal material becomes contaminated, see "Thermal grease" on page 760
- f. Remove the microprocessor protective dust cover, tape, or label from the surface of the microprocessor socket, if one is present.

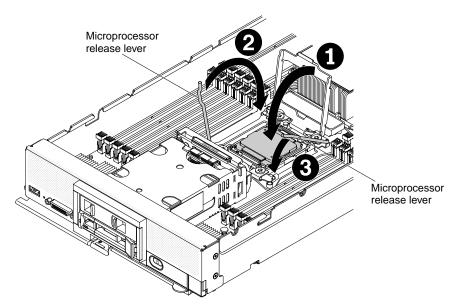
- a. Close the microprocessor retainer on the microprocessor socket.
- b. Identify which release lever is labeled as the first release lever to close (labeled on the microprocessor-retention assembly) and close it.
- c. Close the second release lever on the microprocessor socket.

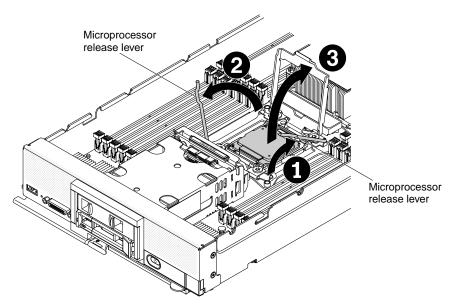
- 1. Use a 5 mm (3/16-inch) nut driver to loosen the screw on one side of the heat sink to break the seal with the microprocessor.
- 2. Use a 5 mm (3/16-inch) nut driver to loosen the screws on the heat sink, rotating each screw two full turns until each screw is loose.
- 3. Gently pull the heat sink from the microprocessor.
- b. Open the microprocessor socket release levers and retainer on the defective system-board assembly.

- 1. Identify which release lever is labeled as the first release lever to open (labeled on the microprocessor-retention assembly) and open it.
- 2. Open the second release lever on the microprocessor socket.
- 3. Open the microprocessor retainer.
- c. Remove the heat-sink filler on the replacement system-board assembly and set it aside.

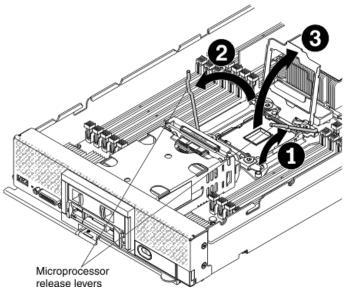
d. Open the microprocessor socket release levers and retainer on the replacement system-board assembly.

- 1. Identify which release lever is labeled as the first release lever to open (labeled on the microprocessor-retention assembly) and open it.
- 2. Open the second release lever on the microprocessor socket.
- 3. Open the microprocessor retainer.
- e. Using the microprocessor installation tool, remove the microprocessor from the socket on the defective system-board assembly.

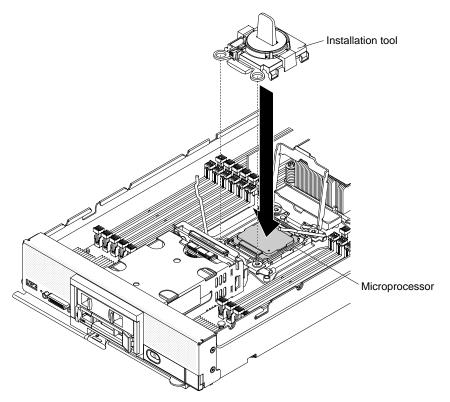
2. Align the installation tool with the screws, as shown in the following graphic, and lower the installation tool on the microprocessor. The installation tool rests flush on the socket only when it is aligned correctly.

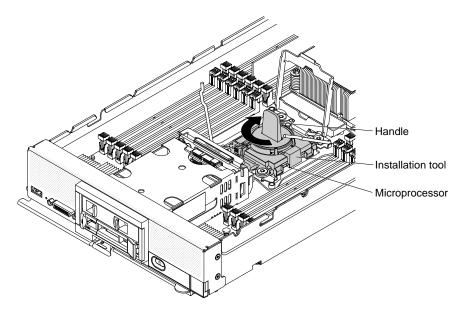
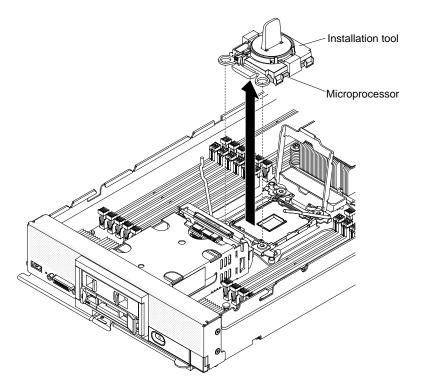
3. Gently twist the handle of the installation tool clockwise until it locks in the "H" or "L" position, depending on the size of microprocessor; then, lift the microprocessor out of the socket.

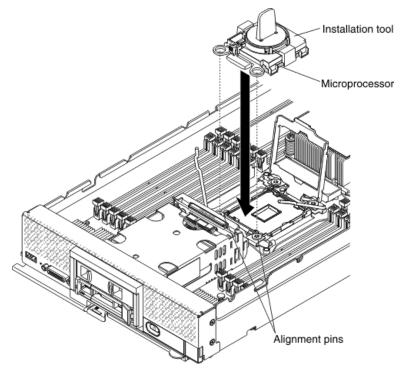
1. Align the installation tool with the microprocessor socket on the replacement systemboard assembly. The installation tool rests flush on the socket only if it is properly aligned.

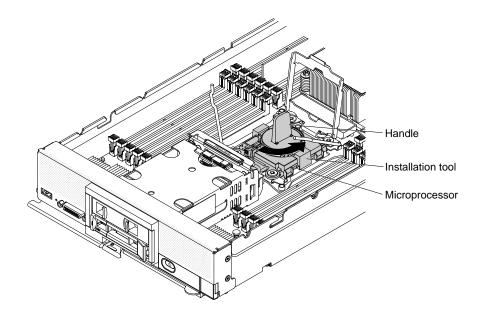
2. Twist the handle of the installation tool assembly counterclockwise until the microprocessor is inserted into the socket, and lift the installation tool out of the socket.

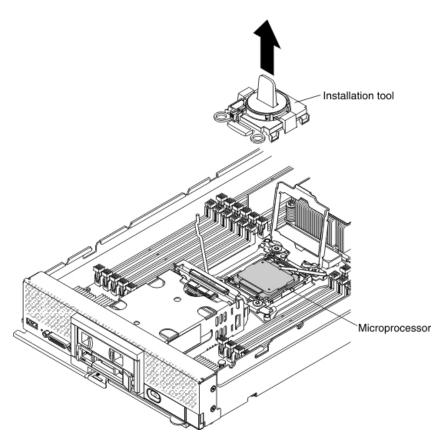
The following illustration shows removing the installation tool handle.

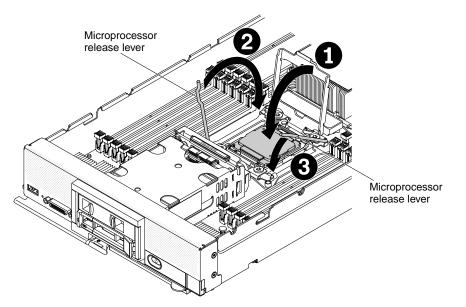
g. Close the microprocessor socket release retainer and levers on the replacement system-board assembly.

- 1. Close the microprocessor retainer on the microprocessor socket.
- 2. Identify which release lever is labeled as the first release lever to close (labeled on the microprocessor-retention assembly) and close it.
- 3. Close the second release lever on the microprocessor socket.

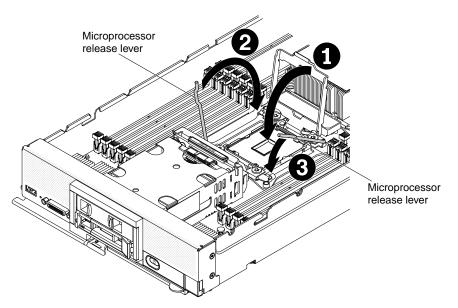
h. Close the microprocessor socket release retainer and levers on the defective system-board assembly.

- 1. Close the microprocessor retainer on the microprocessor socket.
- 2. Identify which release lever is labeled as the first release lever to close (labeled on the microprocessor-retention assembly) and close it.
- 3. Close the second release lever on the microprocessor socket.
- i. Install the heat-sink filler that you removed from the replacement system-board assembly on the defective system-board assembly.
- j. Install the heat-sink that you removed from the defective system-board assembly on the replacement system-board assembly.

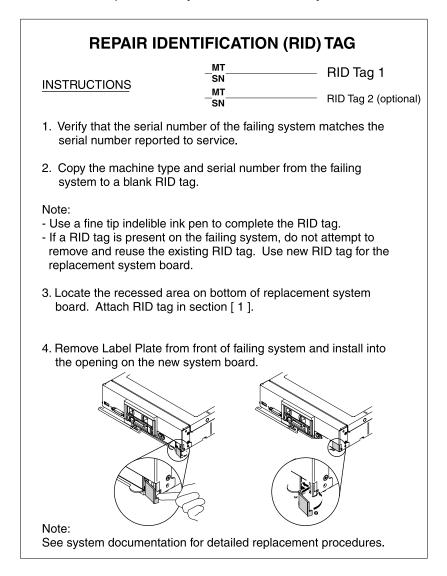
Step 17. The replacement system-board assembly comes with a Repair Identification (RID) tag. Using a fine tip indelible ink pen, transfer the machine type and serial number from the defective system-board assembly to the label on the Repair Identification tag; then, place the tag in the recessed area 1 on the bottom of replacement system-board assembly.
